# TECHNICAL MEMORANDUM

Project: Alewife Brook Sediment Study

Re: FINAL Sediment Sampling and Management Report

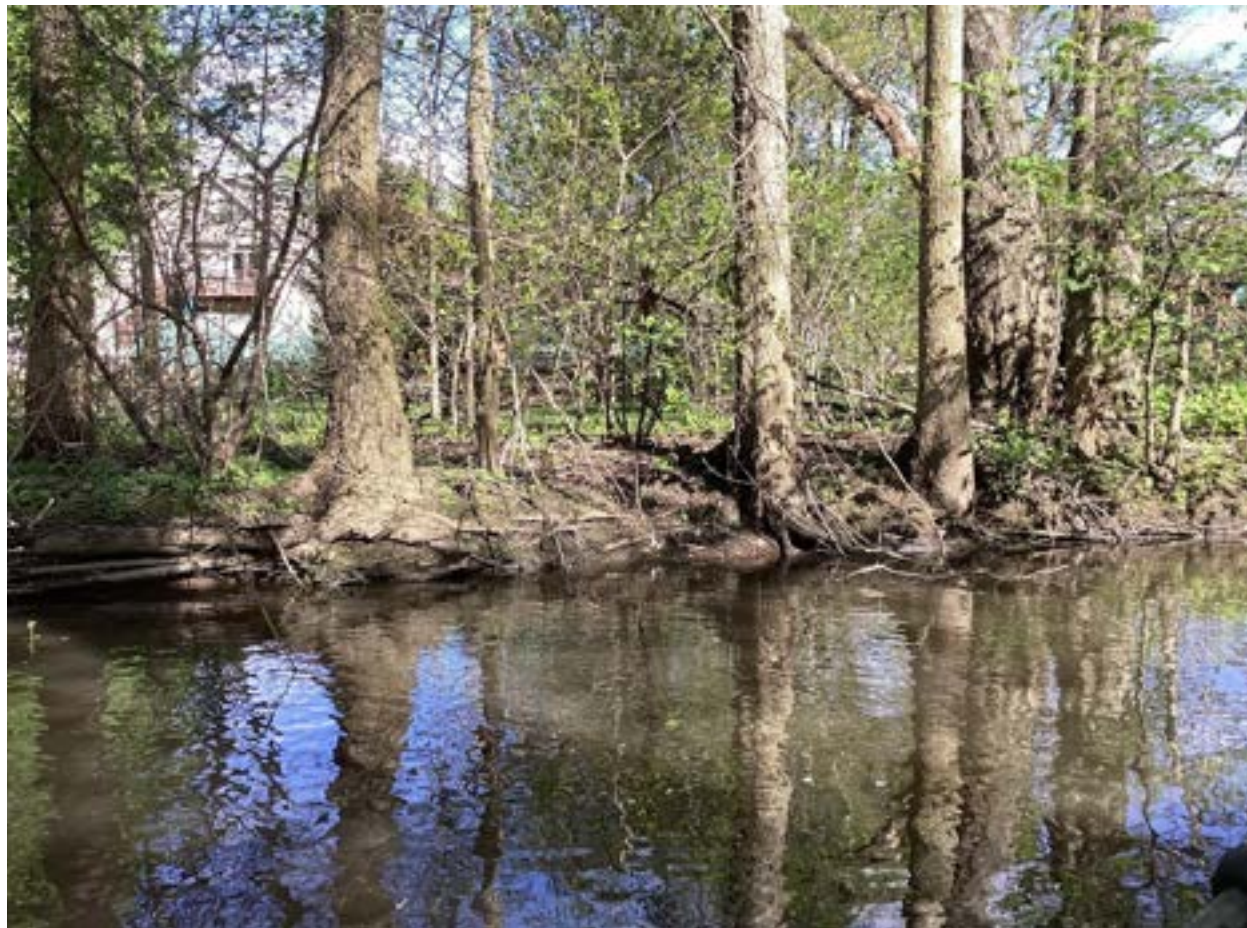
Sub-reach A, which flows parallel to Lafayette St. in Arlington between the Rt. 2 and Mass Ave. bridges, has tree and shrub lined banks. Vegetation, topsoil and tree roots overtop much of the trapezoidal concrete banks in this section (Figure 6). The tree canopy covers 75-100% of the channel, providing shade that limits solar heating of the water. Branches or whole trees that fall into the channel provide in-channel habitat for fish, turtles, birds, and aquatic organisms living in and around Alewife Brook (see images for all reaches in Appendix 1). While they provide important habitat features, the large wood and low hanging branches also make it challenging to navigate the channel in a canoe or other small recreational craft. Woody debris would also increase channel roughness and restrict flow area, which may exacerbate current flooding conditions. The sediment is very organic rich, fine-grained material with some intermittent sand that is easy to probe through. Consistent hard refusal (concrete) was found below approximately 3 ft of sediment throughout section A (Panel 1, Figure 5). This section also has one CSO in the downstream portion, one groundwater pump outfall and 10 stormwater drains directly into the Brook (Figure 4).

***Figure 6. Riparian vegetation overtopping concrete banks on river left in Reach A.***

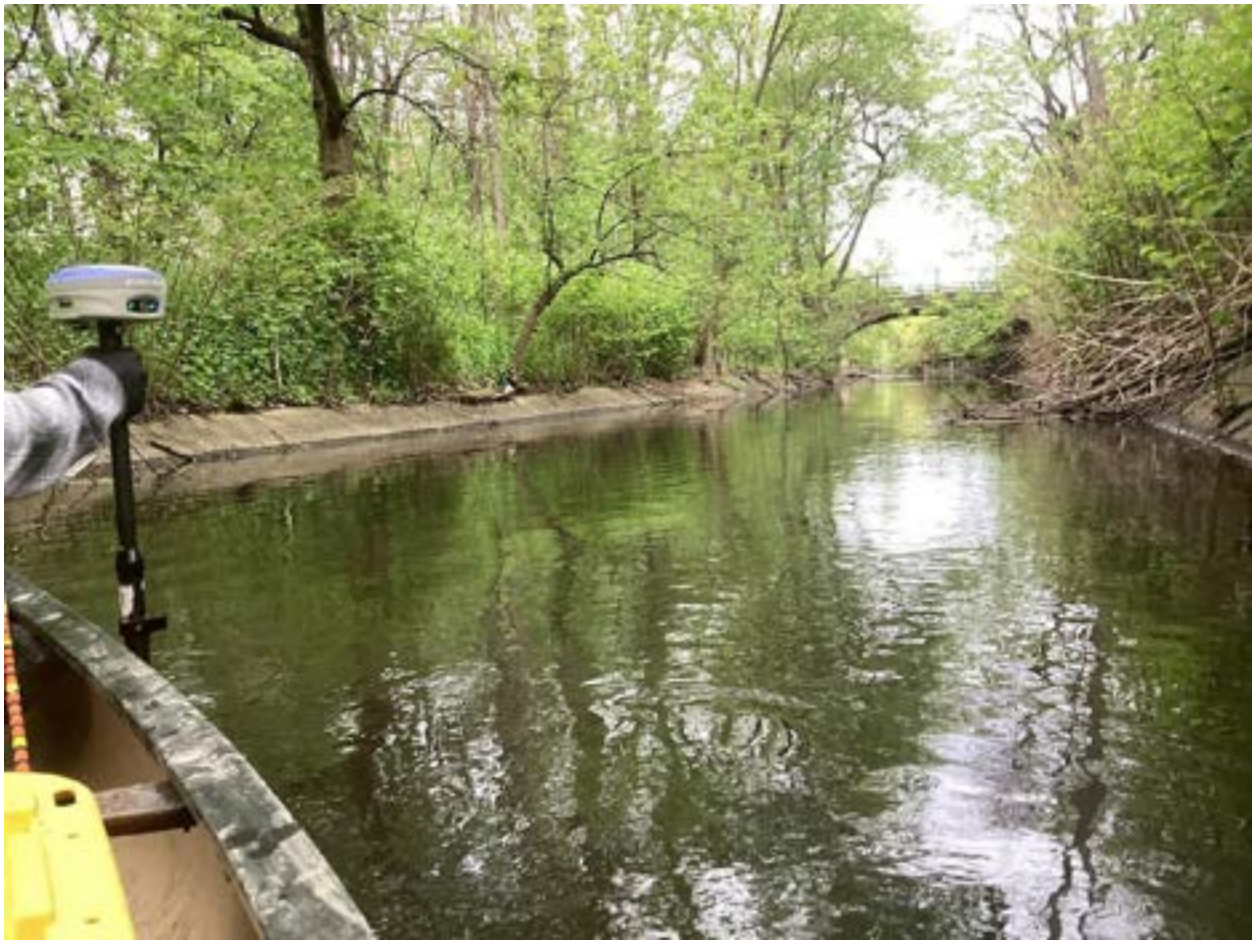
Sub-reach B, from Massachusetts Ave. to Henderson St., has a similar concrete lined geometry to section A but with several CSOs just downstream of Massachusetts Ave (Figure 4), and lots of accumulated trash floating on the surface of the brook. Sub-reach B has approximately 50% overall tree

canopy cover, which results in noticeably less in-channel woody debris compared to Section A. The concrete banks are exposed throughout the majority of this section. The river left and right bank is dominated by invasive Japanese Knotweed through portions of this sub-reach (Figure 7). Sediment characteristics are very similar to the upstream section with highly organic, dark, fine-grained material with intermittent sandy lenses. Overall, sediment accumulation in sub-reach B is approximately 2 ft with some areas closer to 2.5 ft (Figure 5).

**Figure 7. Sub-reach B looking downstream towards Henderson St. Invasive Japanese Knotweed abundant on both banks.**

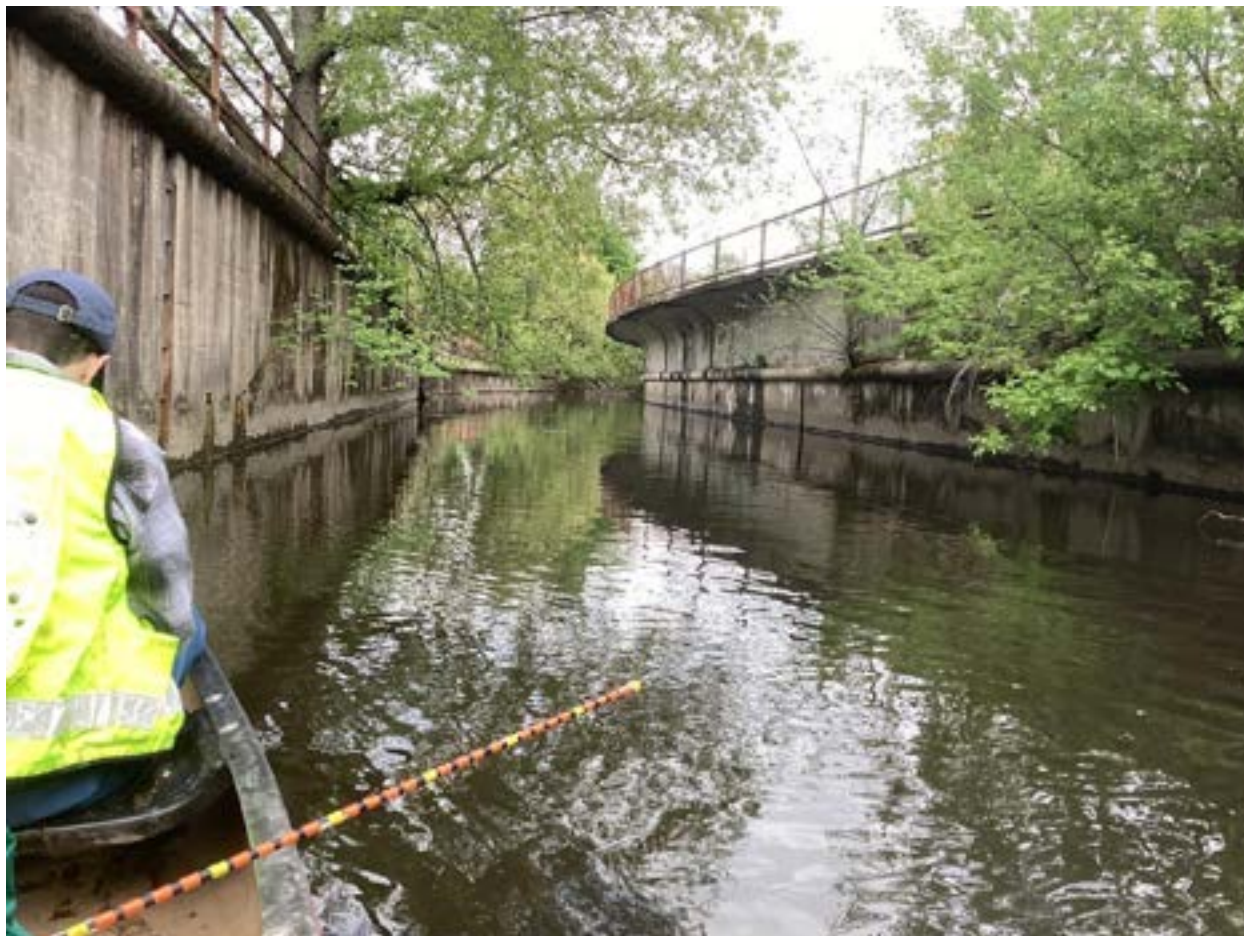
Sub-reach C, from Henderson St. to Broadway, is the first section in the project area that does not have a concrete lined channel throughout. Immediately downstream of Henderson St. the river left bank is exposed soil with trees and shrubs for about 60-70 ft before the beginning of a vertical concrete wall at St Paul's cemetery in Arlington. The concrete walls continue on both sides of the brook for the remainder of the sub-reach C (Figure 8). The concrete walls are built on a poured concrete base, which does not cover the bottom of the channel like in the upstream sections. The remaining substrate in this stretch is a gravel/rock river bottom with overlying fine grained, organic rich sediment consistently 2.0 - 2.25 ft thick (Figure 5). There are several large trees that overhang the channel from the cemetery as well as smaller trees growing out of cracks and ledges in the concrete. There was a large, downed tree with shrubs growing out of it on the river left bank downstream of Henderson St. prior to the cemetery.

The material impounded in this section is organic rich with significant accumulation of leaf litter trapped behind a second downed tree approximately 500 ft downstream of the Henderson St. Bridge.

**Figure 8. Sub-reach C, looking downstream with concrete lined walss on either side of the channel. St Pauls cemetery above on river left.**

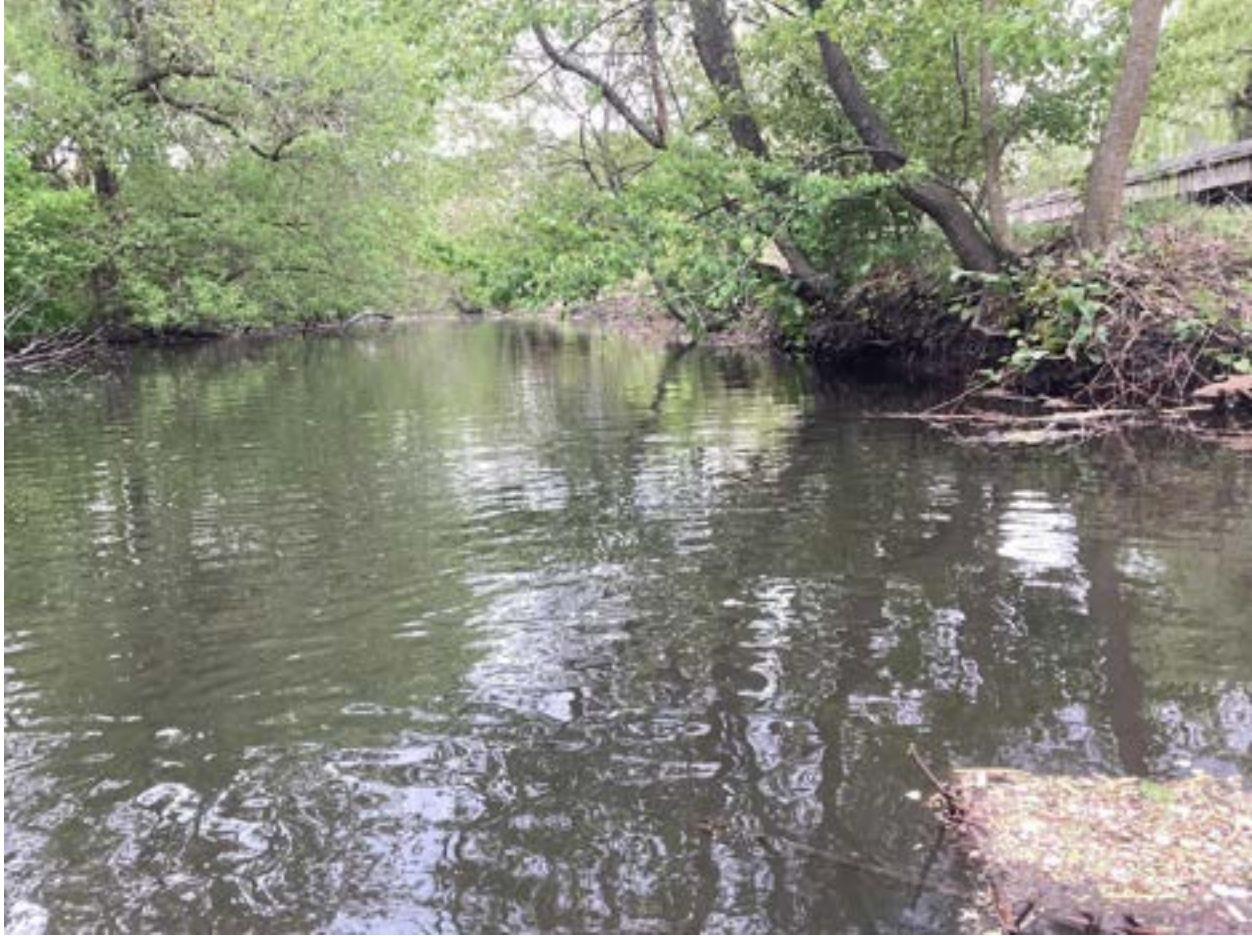
Sub-reach D, from Broadway to the Mystic River confluence, also does not have a continuous concrete channel; the banks are earthen with intermittent rip rap and other stabilizing measures (Figure 9). This includes chunks of concrete and large rock that are remnants of rip rap or other concrete scattered around the banks and in the channel. This varied material creates a substrate of irregular concrete, gravel and rock with fine grained material accumulated on top. Downstream of Broadway, the concrete walls stop and the riverbanks are lined with dense trees and shrubs for the majority of the approximately 2900-ft section. The thick vegetation results in leaf litter on the banks and approximately 50-75% tree canopy cover. There are several stormwater drains into the brook and some minor in-channel woody material but no large channel-spanning wood. Sediment accumulation is approximately 2.0 - 2.5 ft throughout this section of similarly organic rich fine-grained material (Figure 5).

**Figure 9. Reach D. Looking upstream. The undercut banks and overhanging vegetation provide in-channel aquatic cover and habitat.**

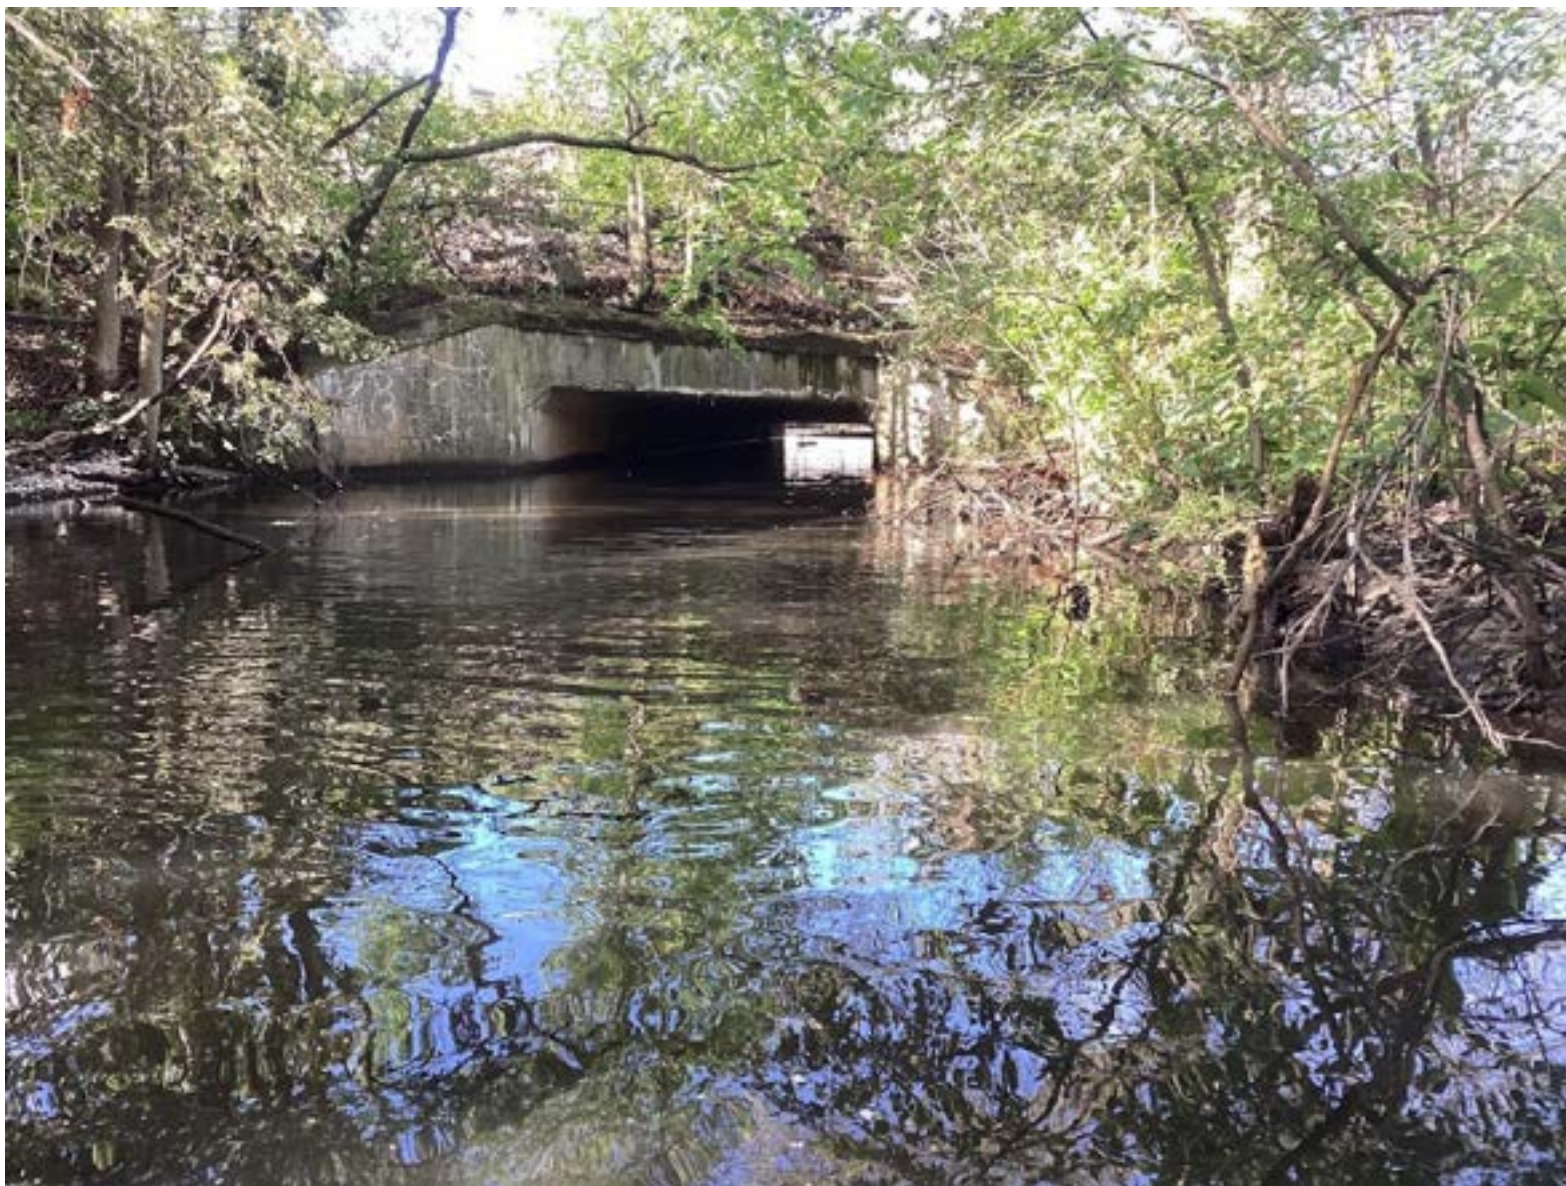
*Figure 1. Reach A. Looking upstream at the Rt 2 Bridge with trees and shrubs growing on the concrete banks.*

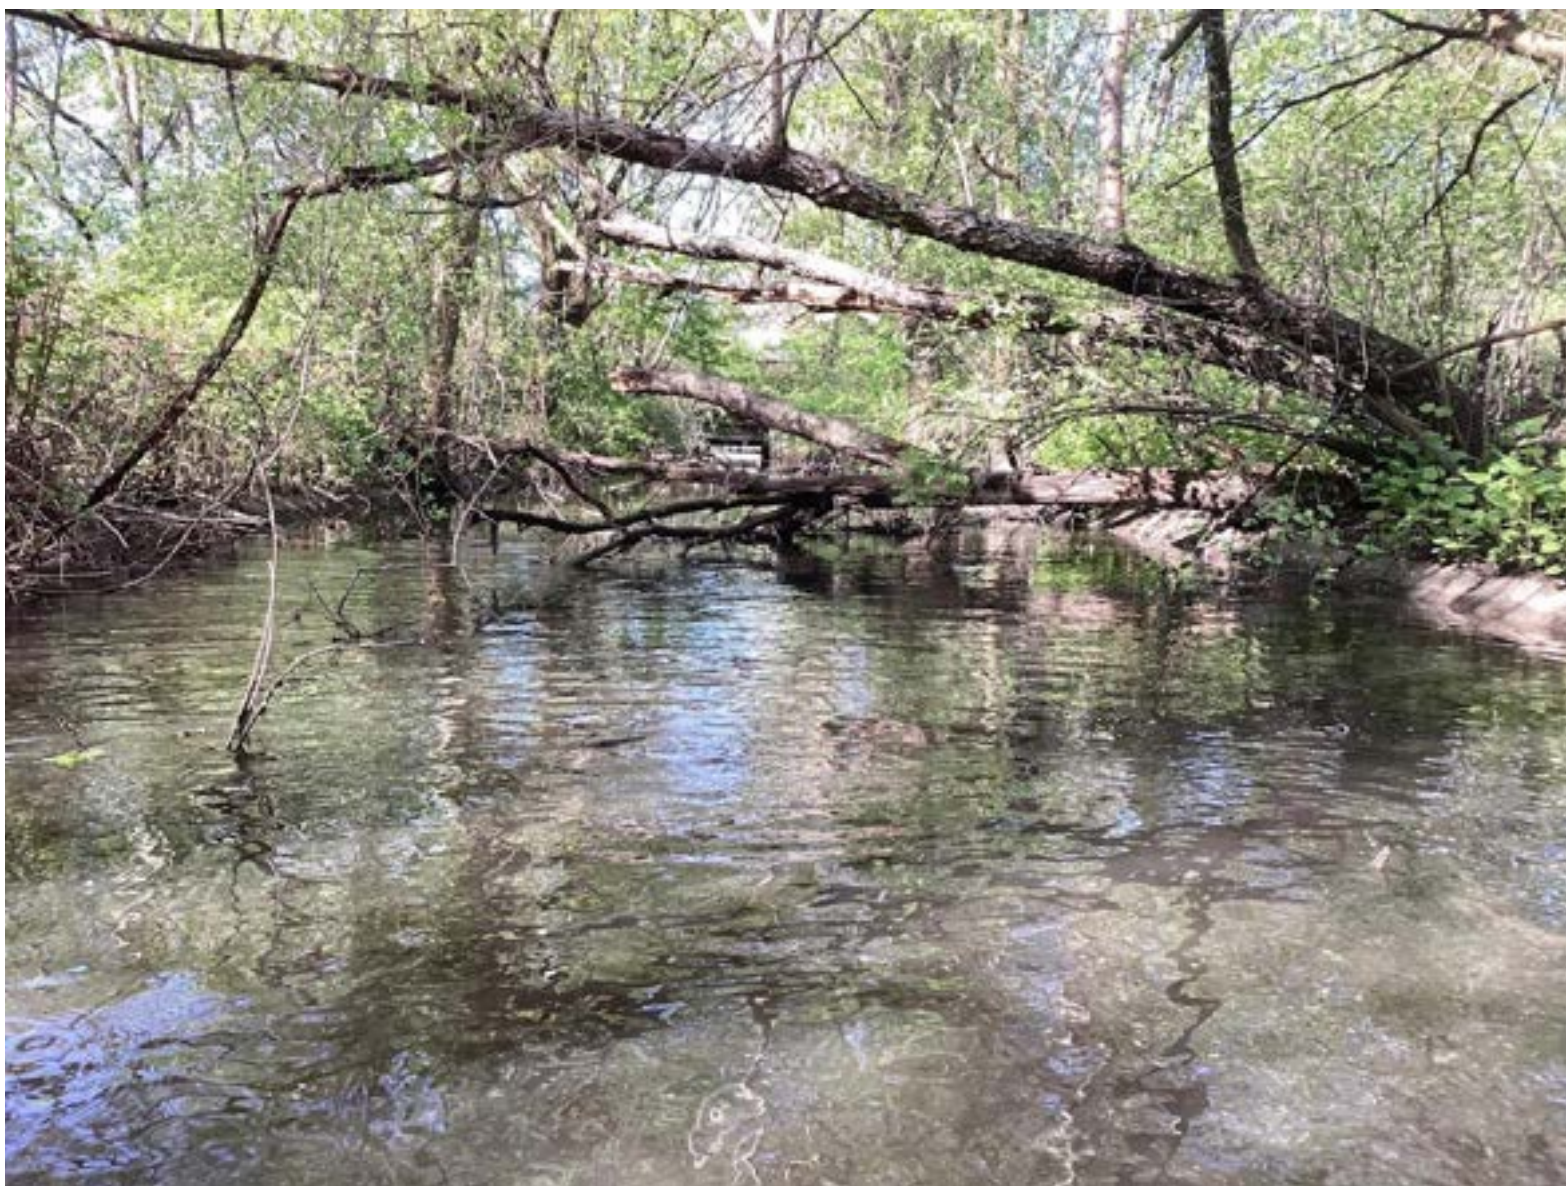
*Figure 2. Reach A Looking upstream at the Route 2 bridge with fallen trees creating large wood habitat within the channel.*

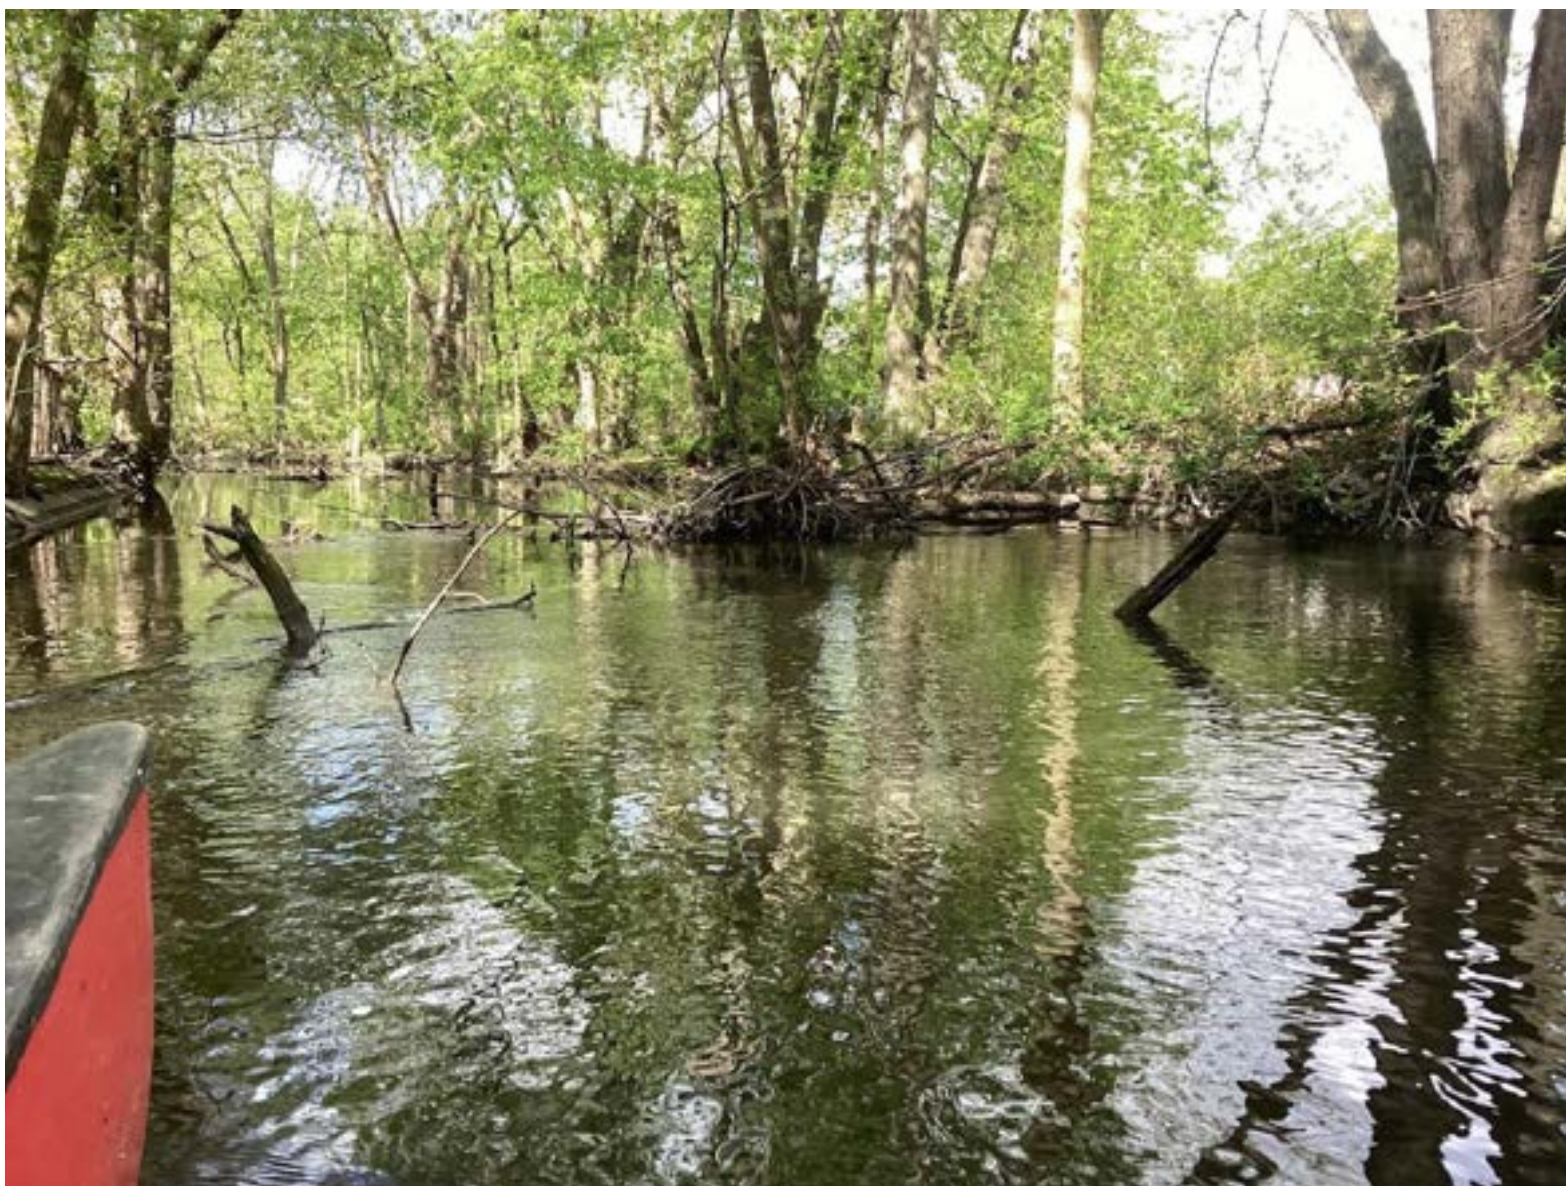
*Figure 3. Reach A. Looking downstream at large wood fallen from the channel banks providing in-channel aquatic habitat.*

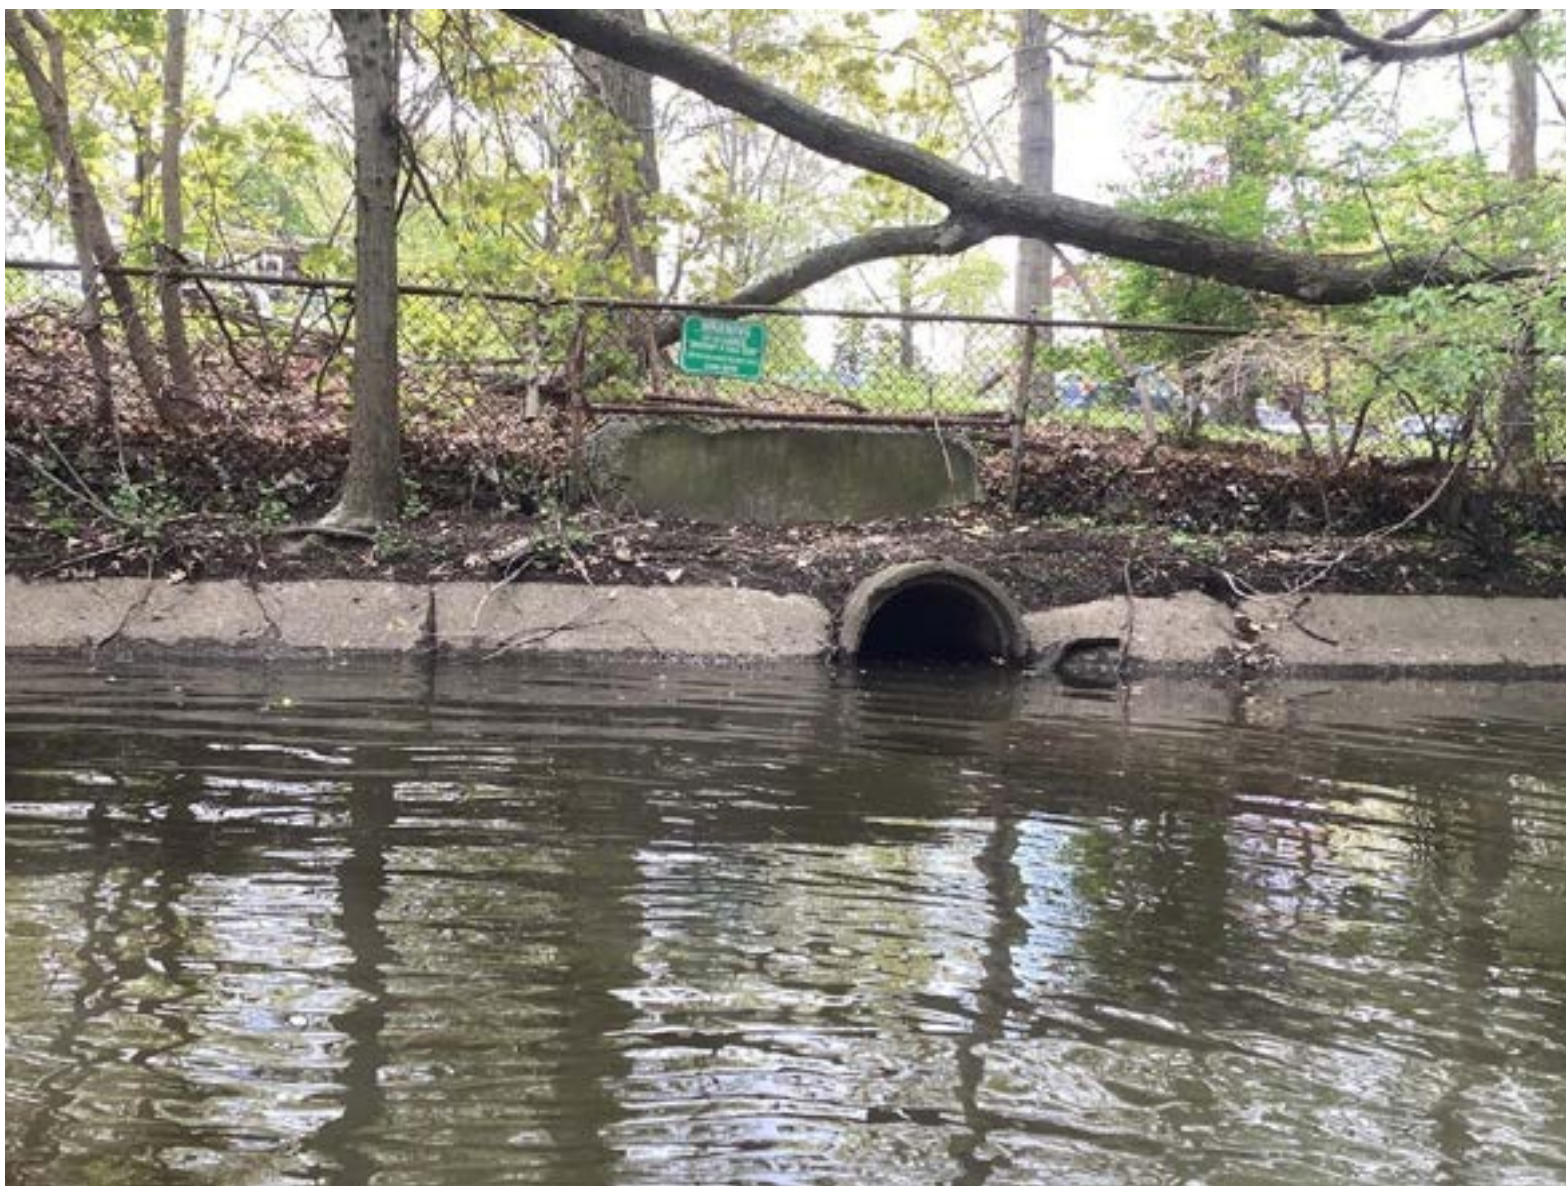
*Figure 4. Reach A. Combined Sewer Outflow (CSO) CAM401B just upstream of Massachusetts Ave.*

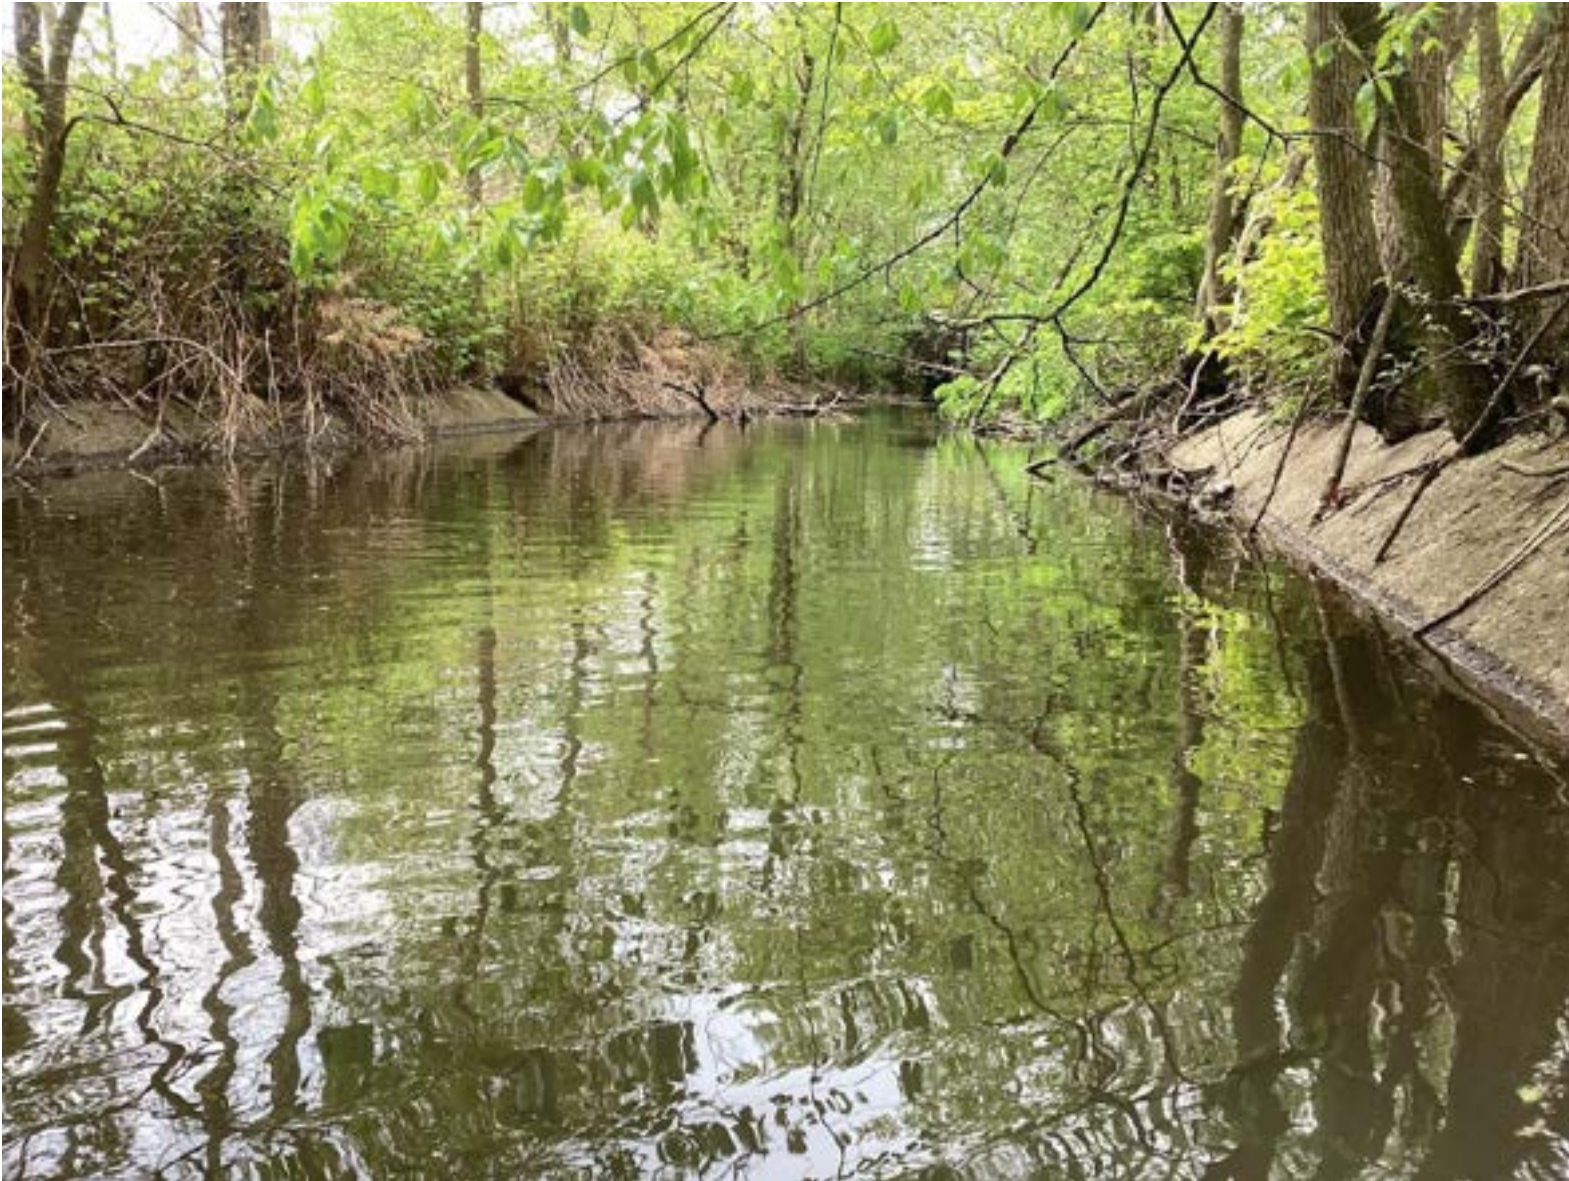
*Figure 6. Reach B. Looking downstream. Note the invasive Japanese knotweed growing on top of both concrete banks.*

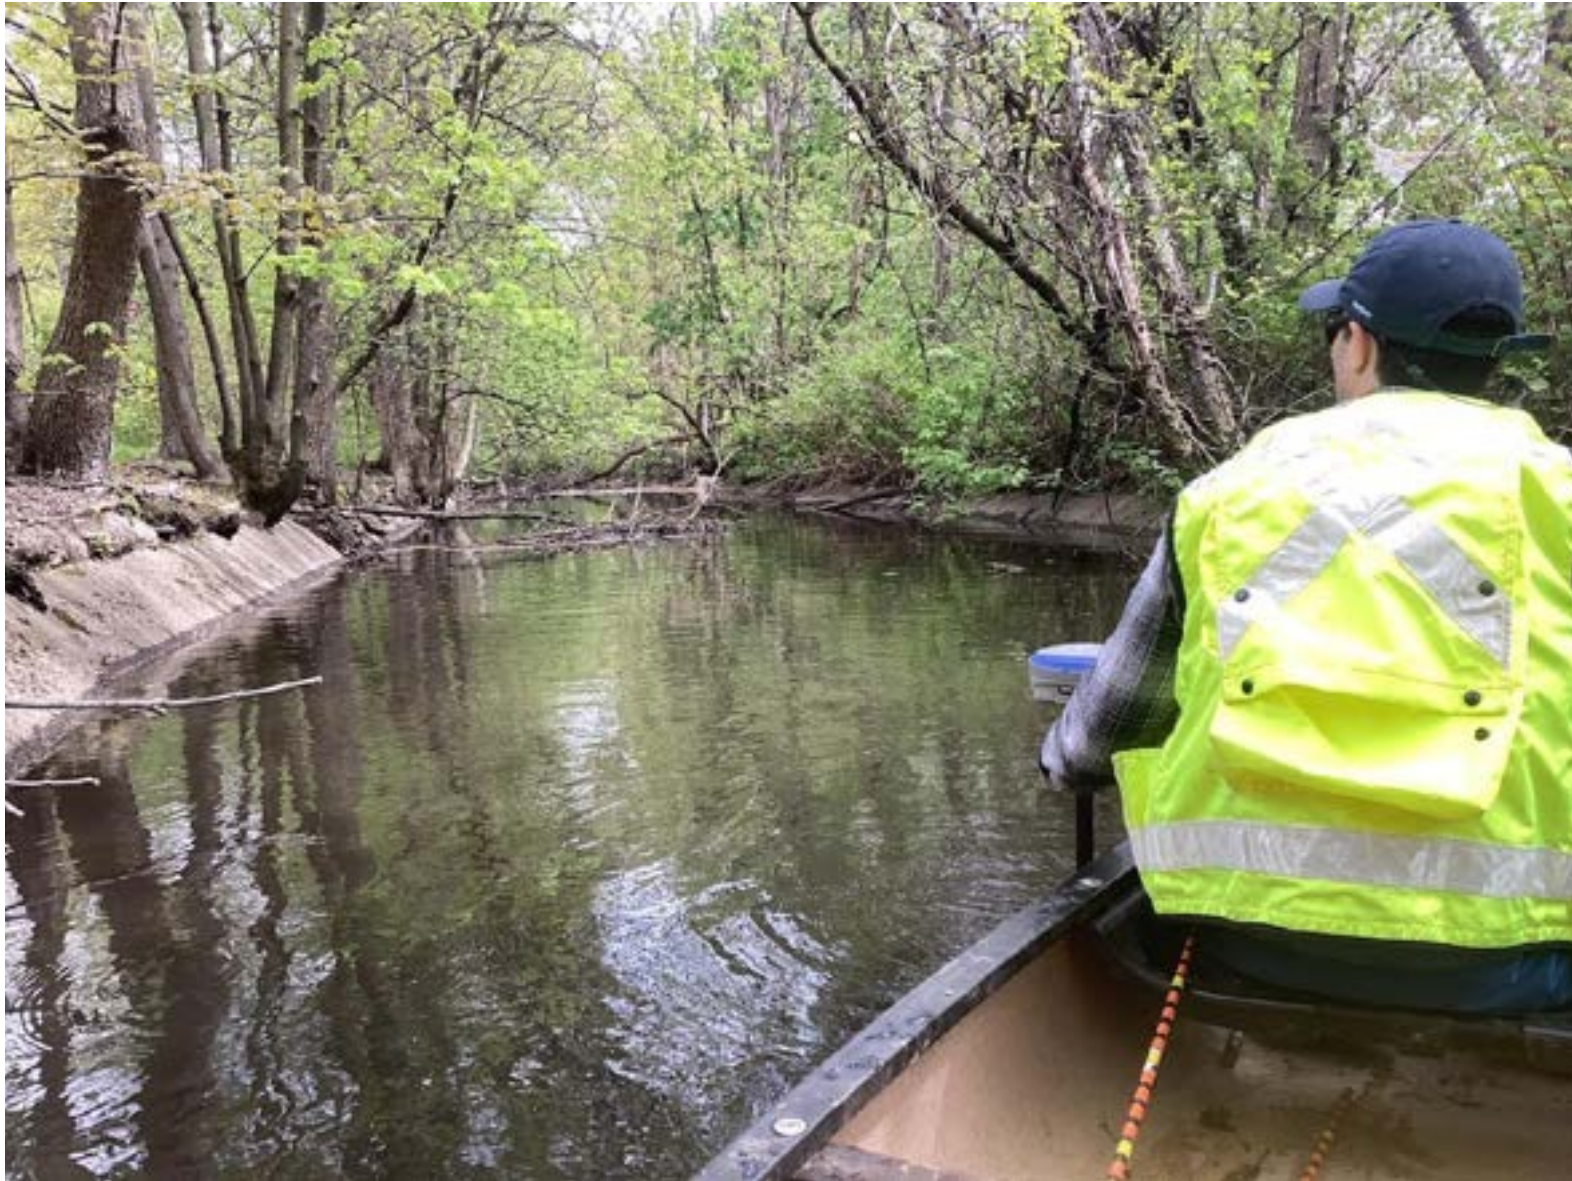
*Figure 7. Reach B. Looking downstream at in-channel wood from fallen trees and branches.*

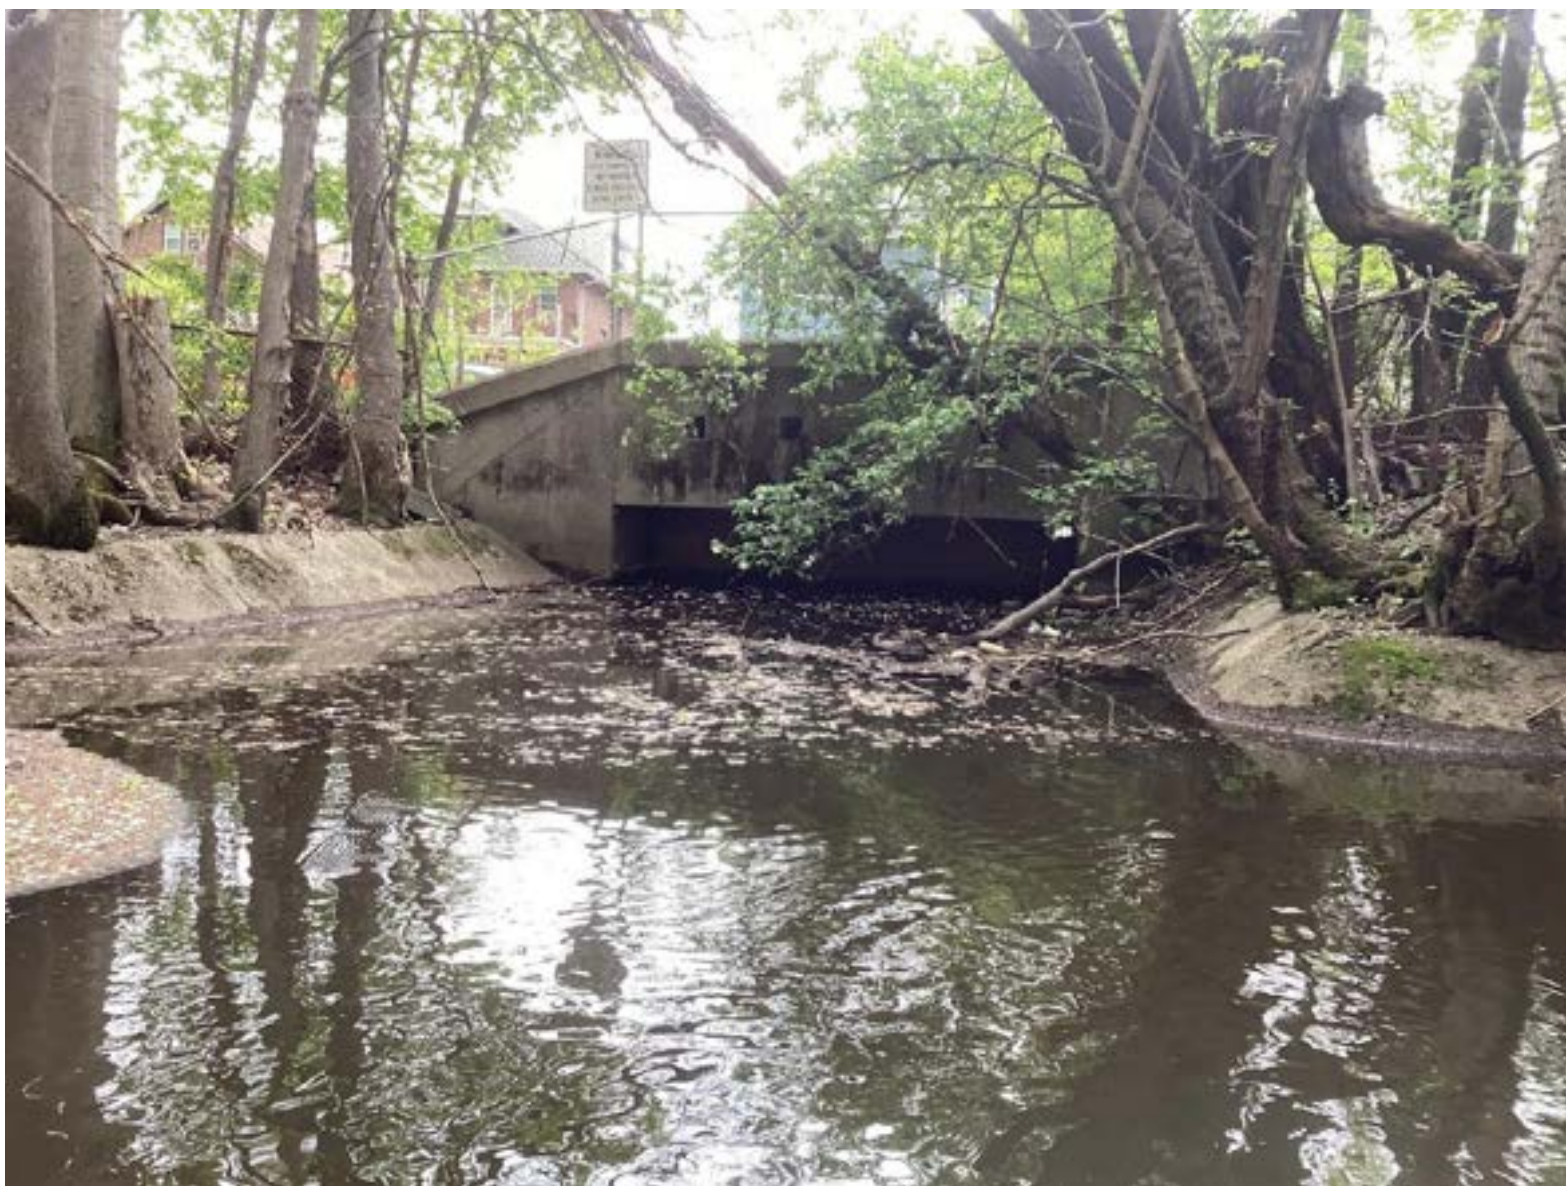
*Figure 8. Reach B. Somerville CSO,CAM001 river right.*

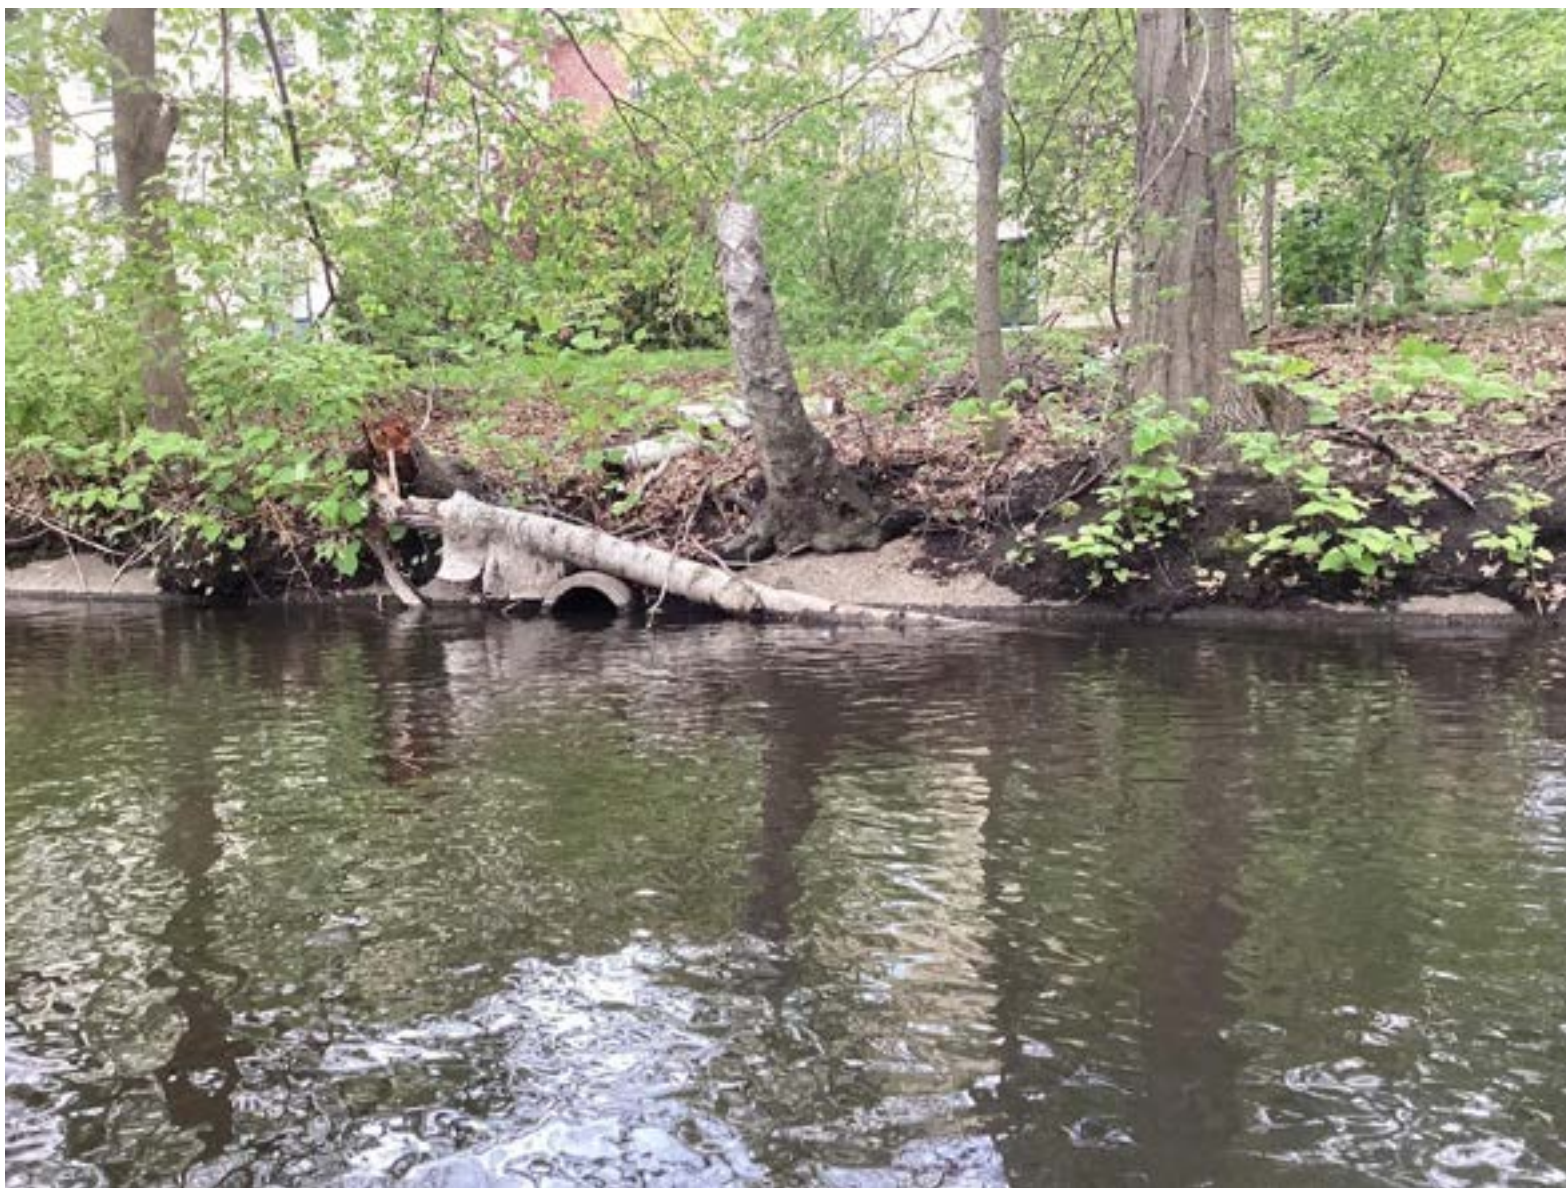
*Figure 9. Reach B. River right bank with stormwater drain. Throughout this reach, tree roots and topsoil overtop the concrete banks.*

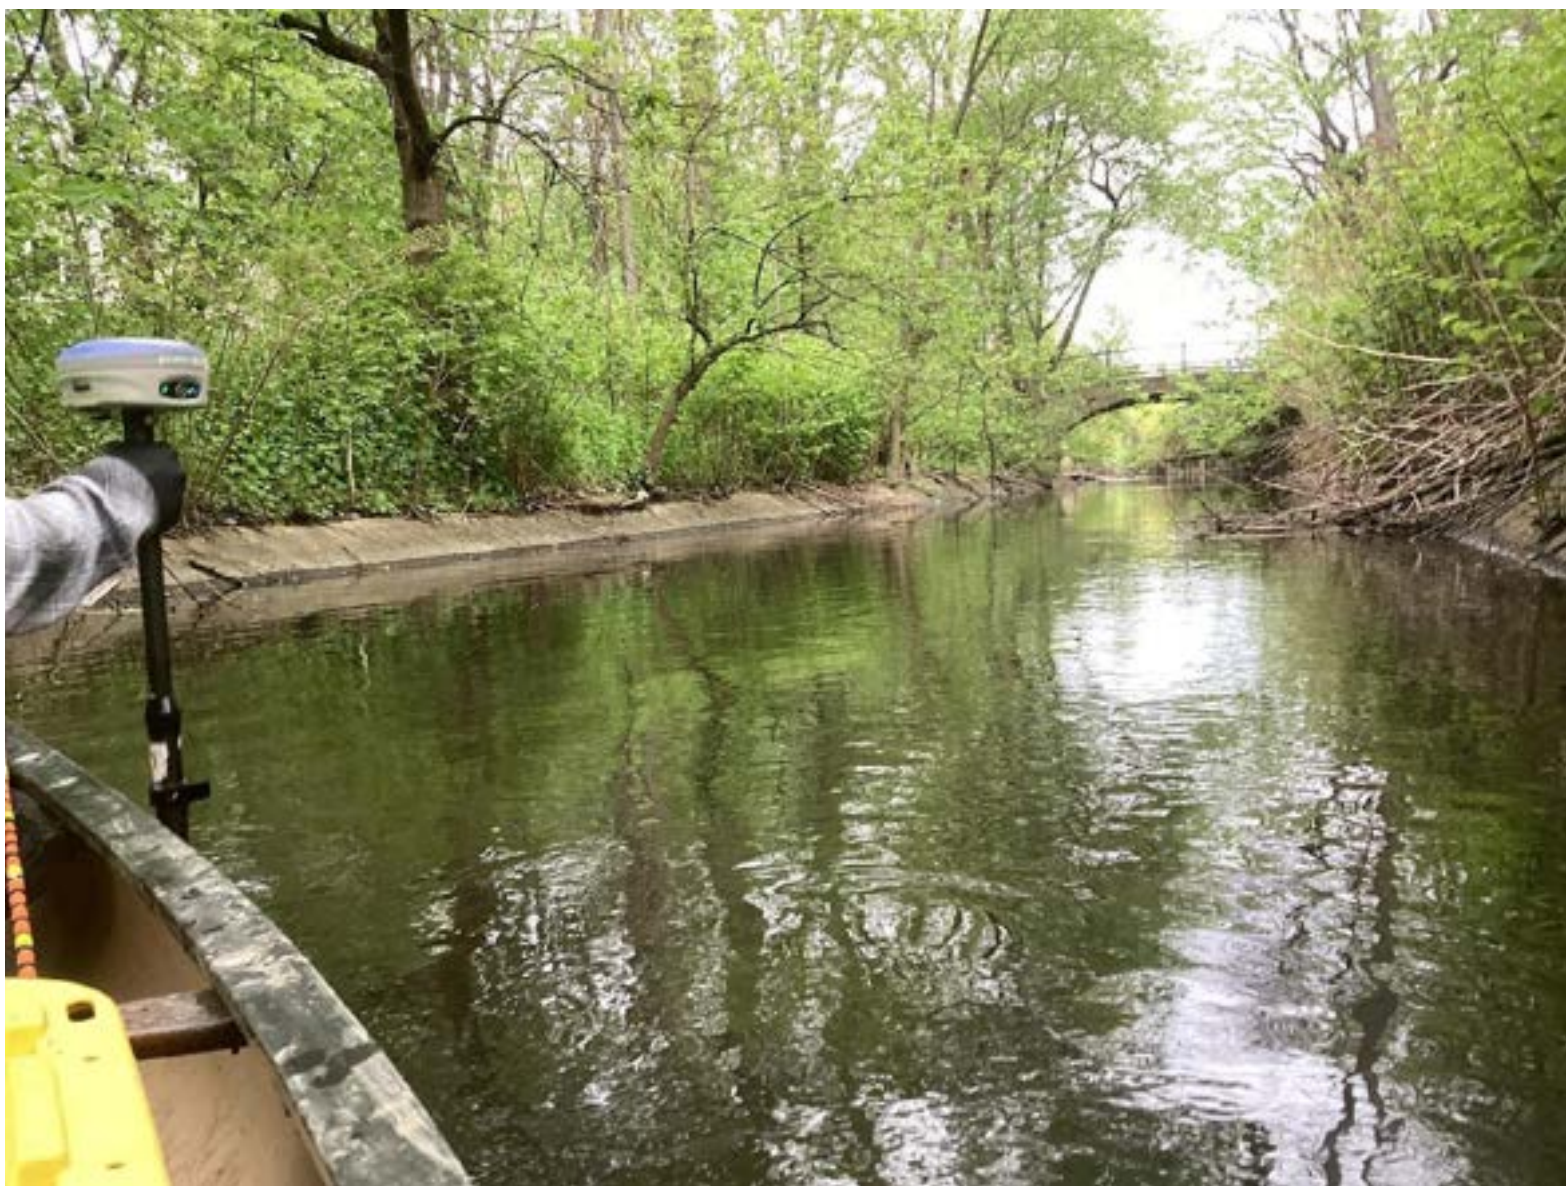
*Figure 10. Reach B. Looking downstream towards the Cross St. bridge. Both banks are overgrown with the invasive Japanese knotweed.*
