# TECHNICAL MEMORANDUM

Project: Alewife Brook Sediment Study

Re: FINAL Sediment Sampling and Management Report

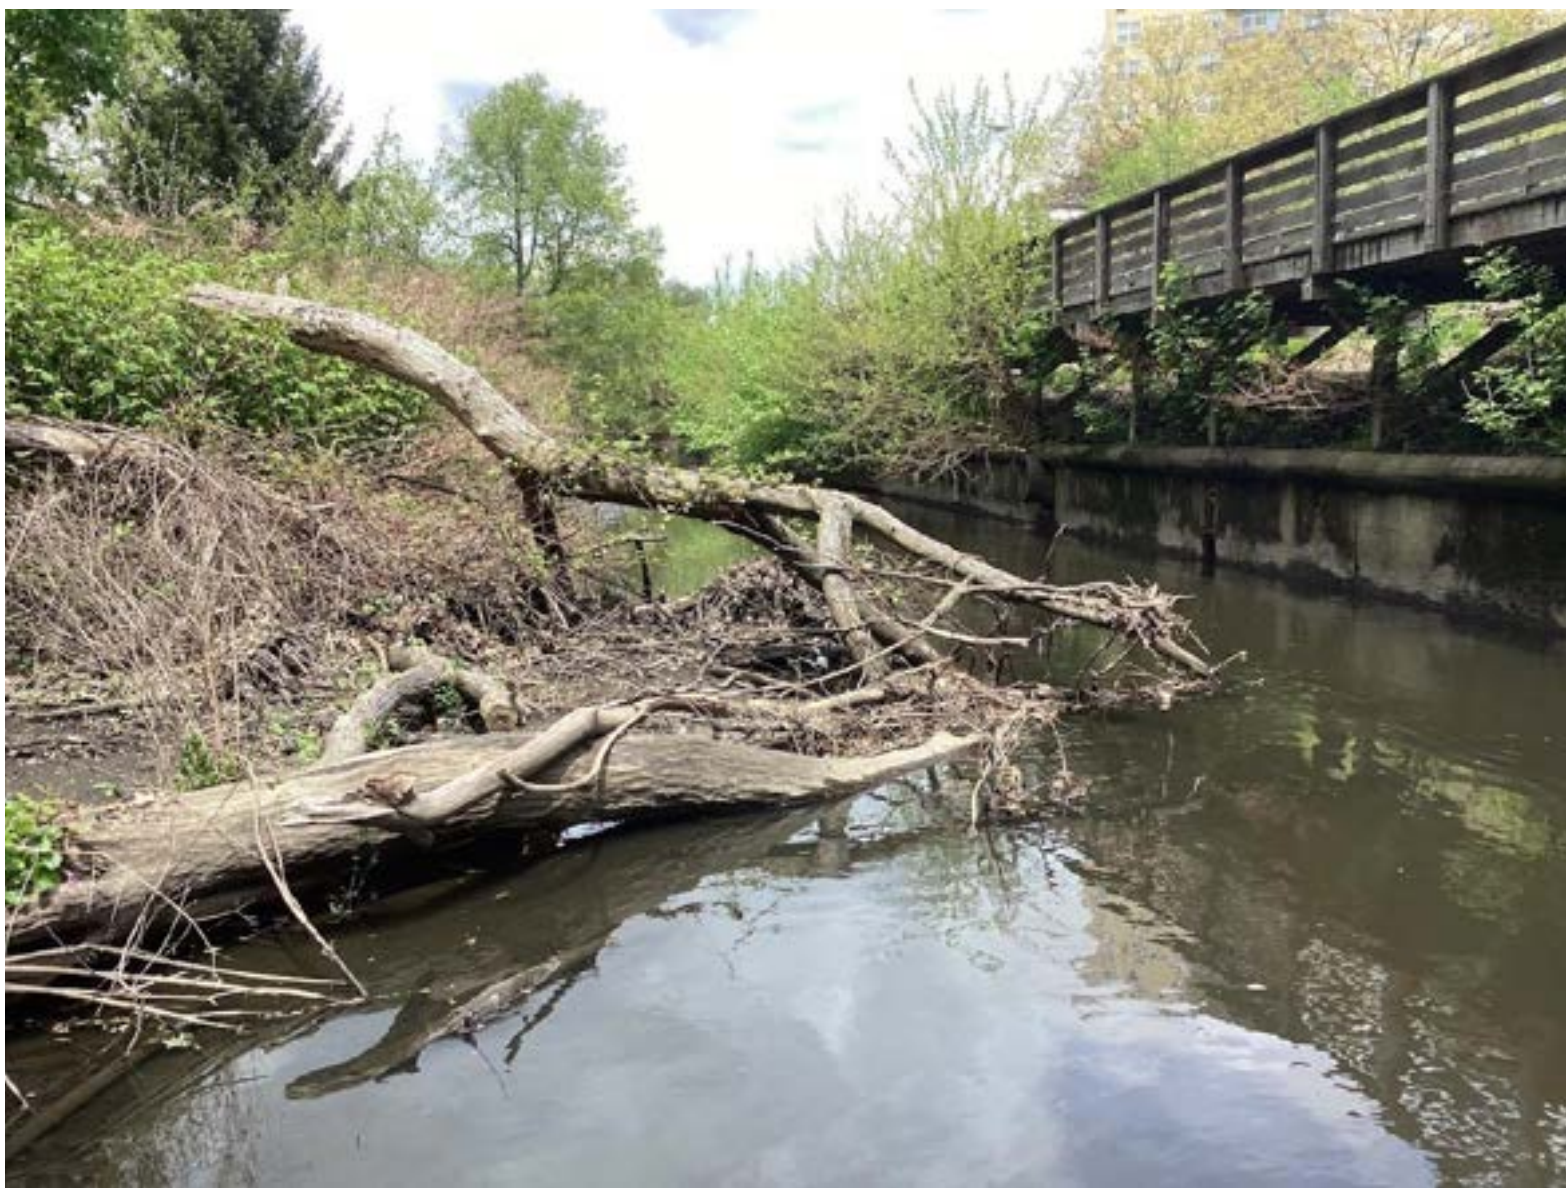
*Figure 12. Reach C. Looking downstream with a large downed tree and log jam river left and the elevated boardwalk along Alewife Brook Parkway in the top right.*

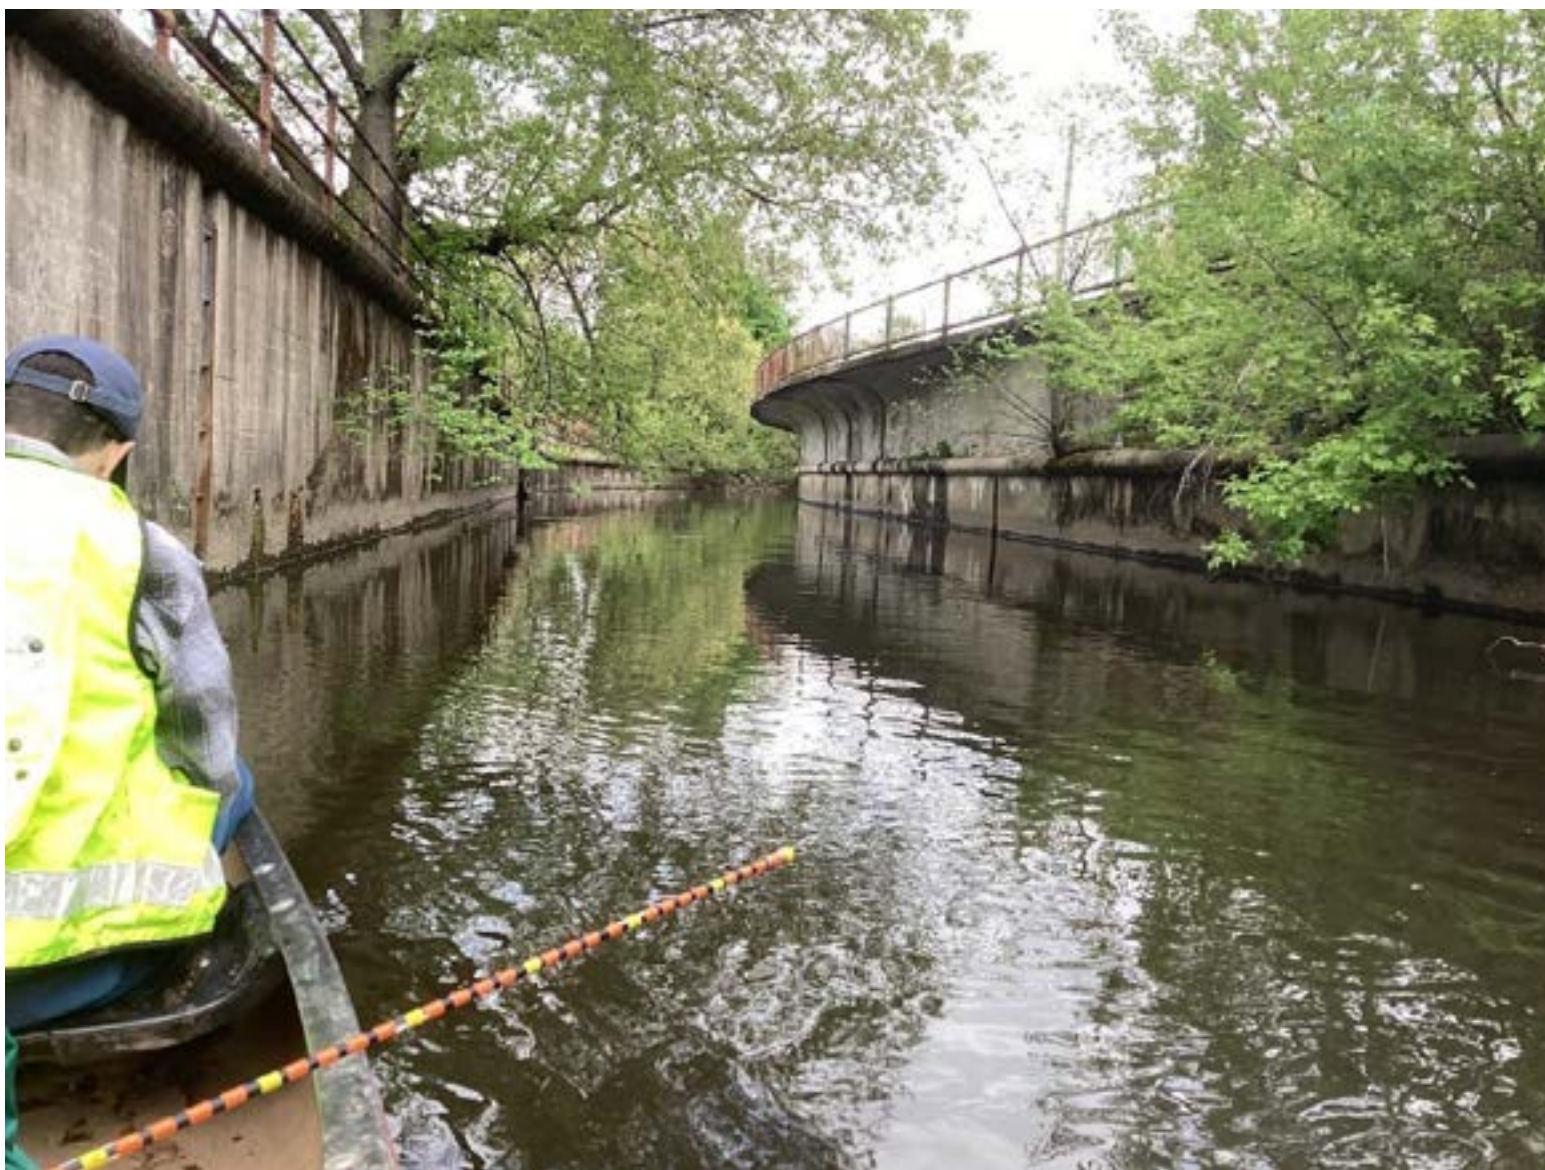
*Figure 13. Reach C. Looking downstream at the vertical concrete wall on the left below St. Paul's Cemetery and the vertical and overhanging concrete walls on river right. Note the trees growing out of cracks within the concrete walls on river right.*

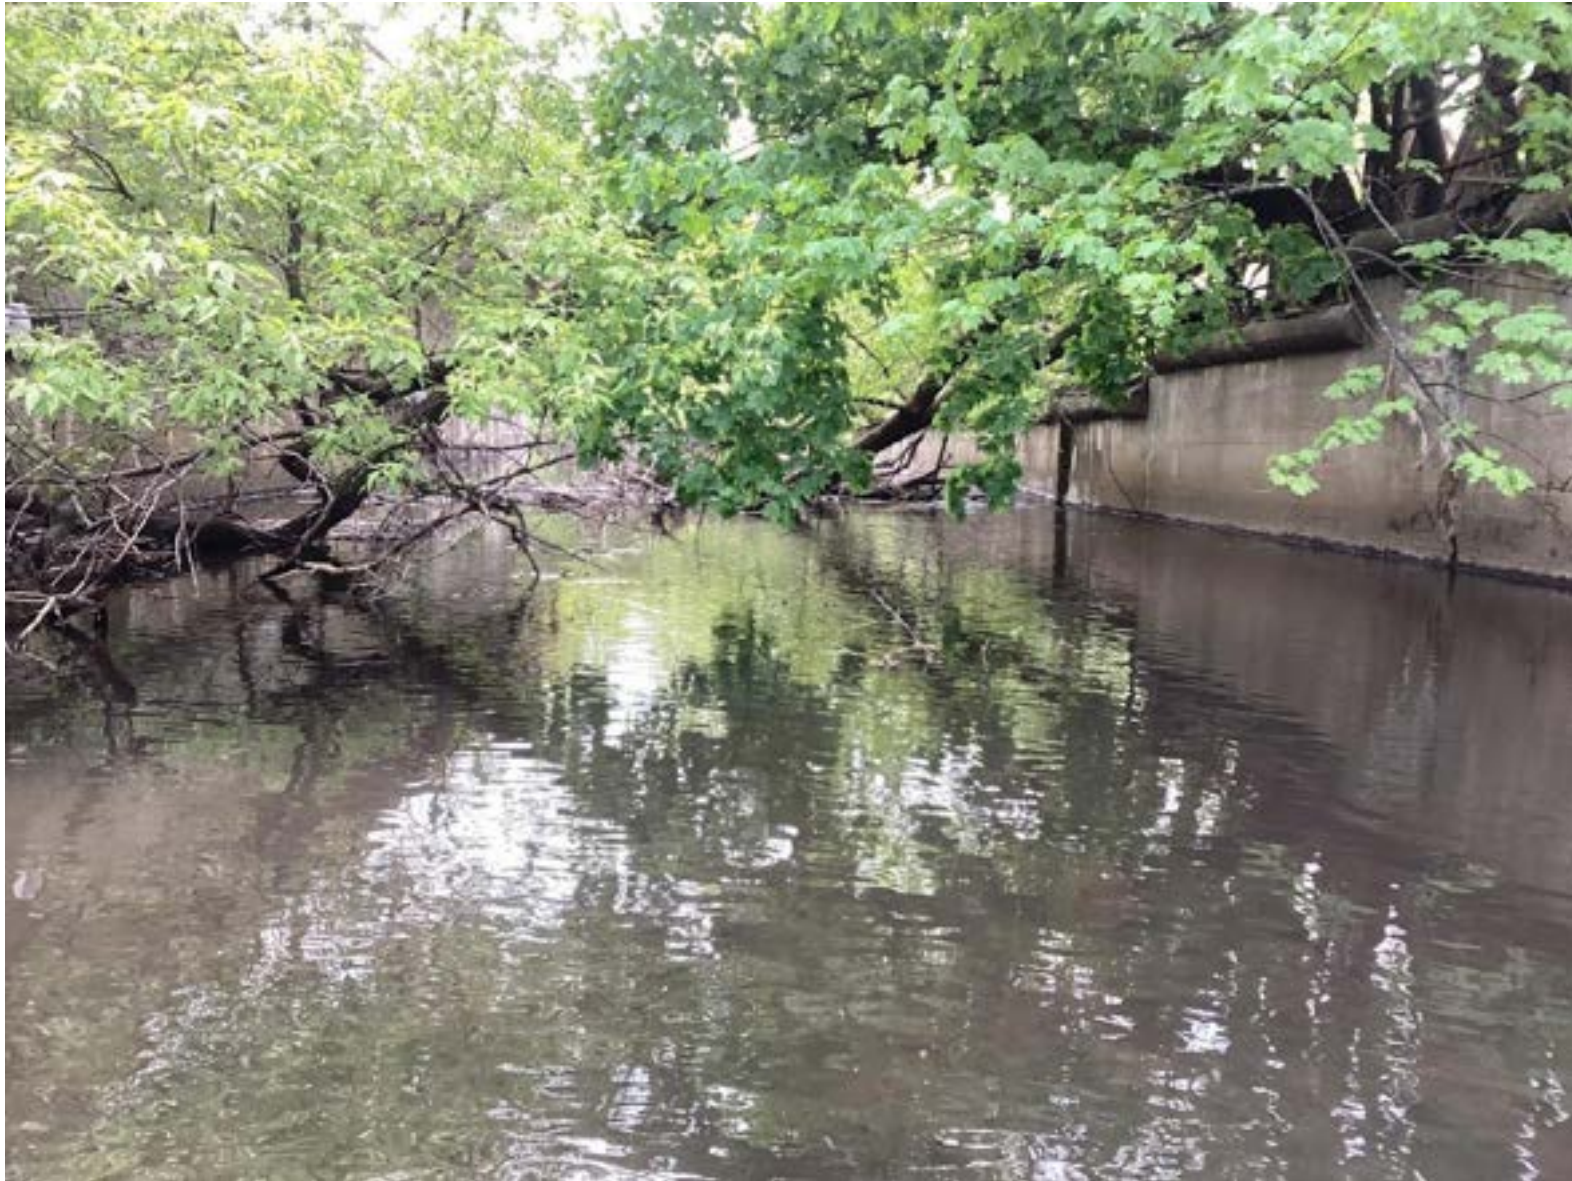
*Figure 14. Reach C. Looking downstream towards a large fallen branch.*

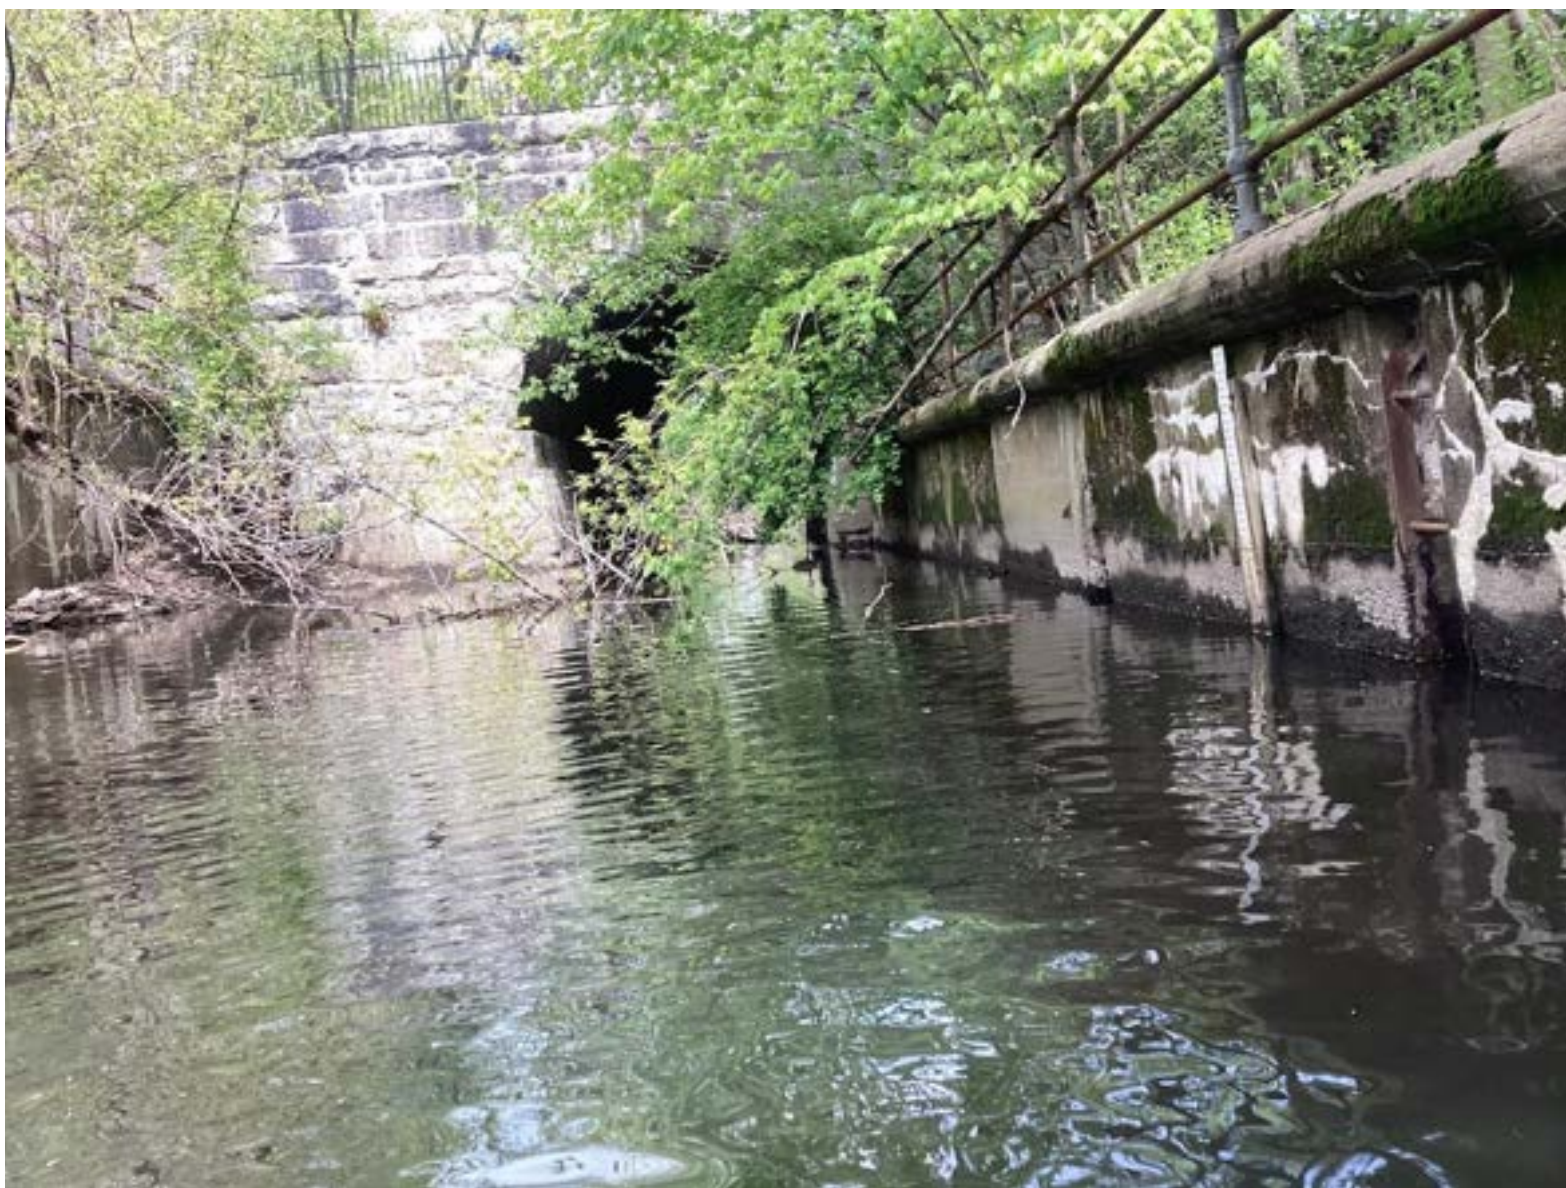
*Figure 15. Reach C. Looking downstream towards the bridge at Broadway. Concrete walls line both sides of the channel throughout most of Reach C.*

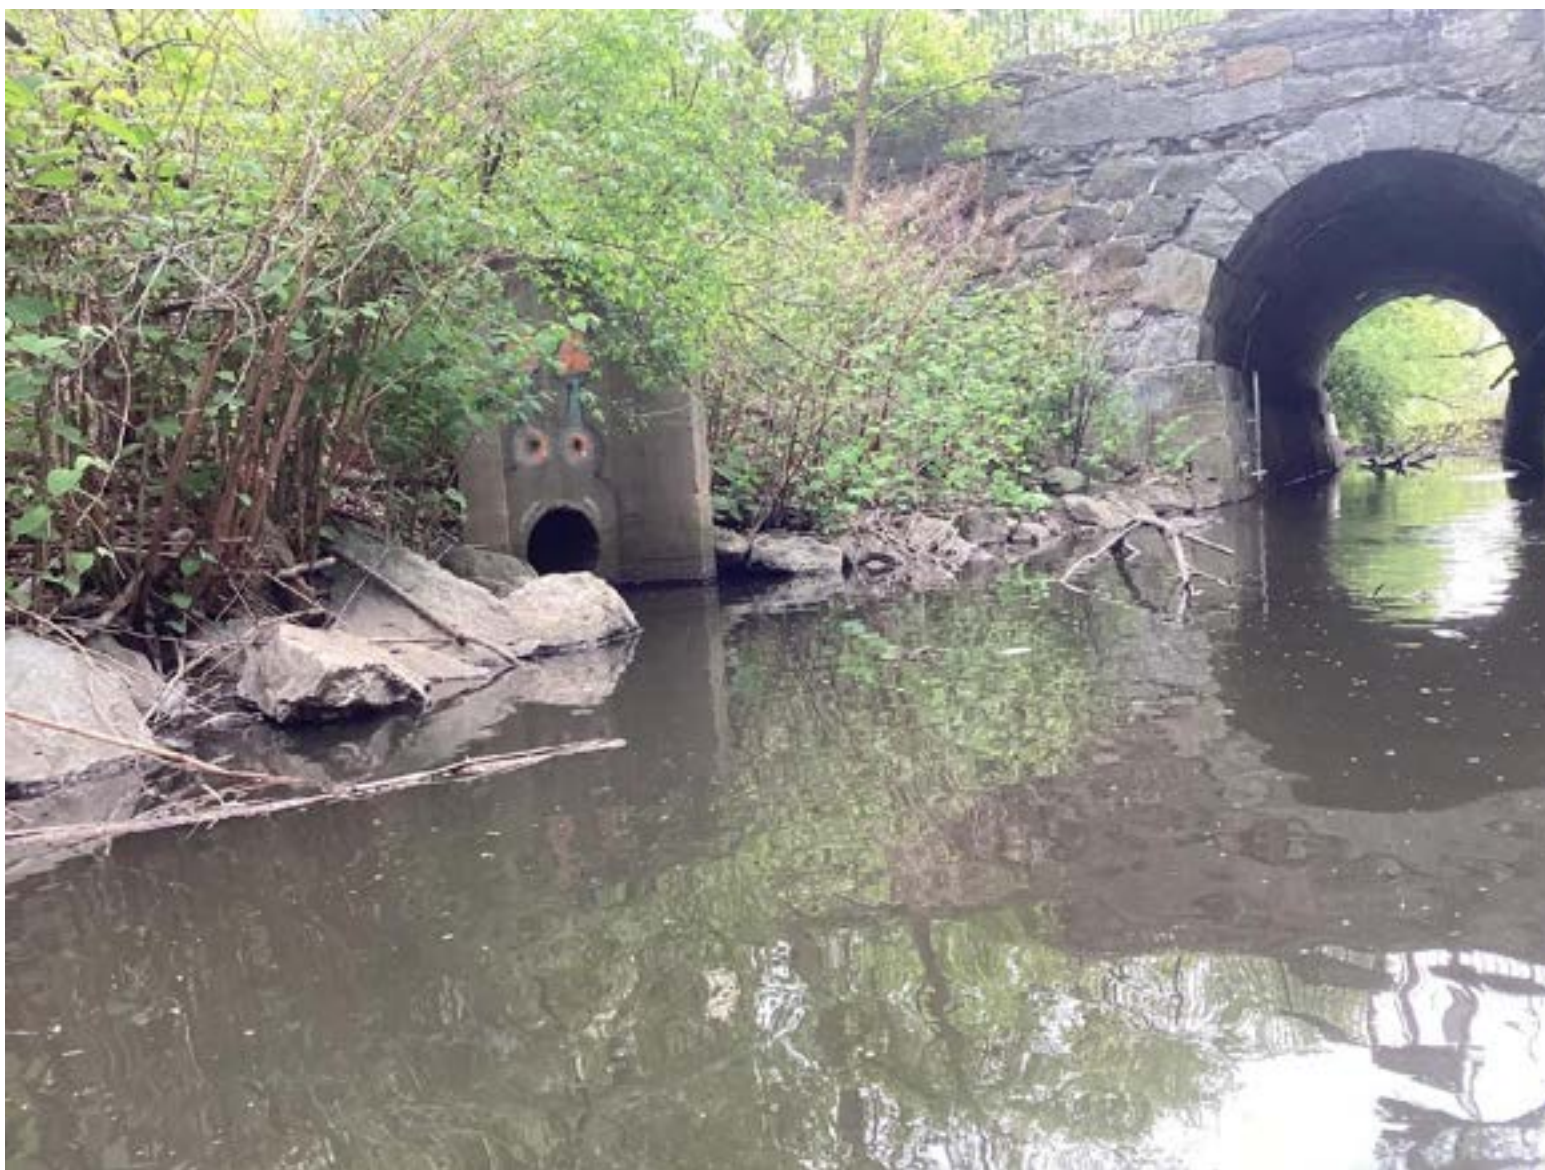
*Figure 16. Reach D. Looking upstream towards the bridge at Broadway and river right bank. The stormwater drain on the river right bank is surrounded by concrete rip rap and the invasive Japanese knotweed.*

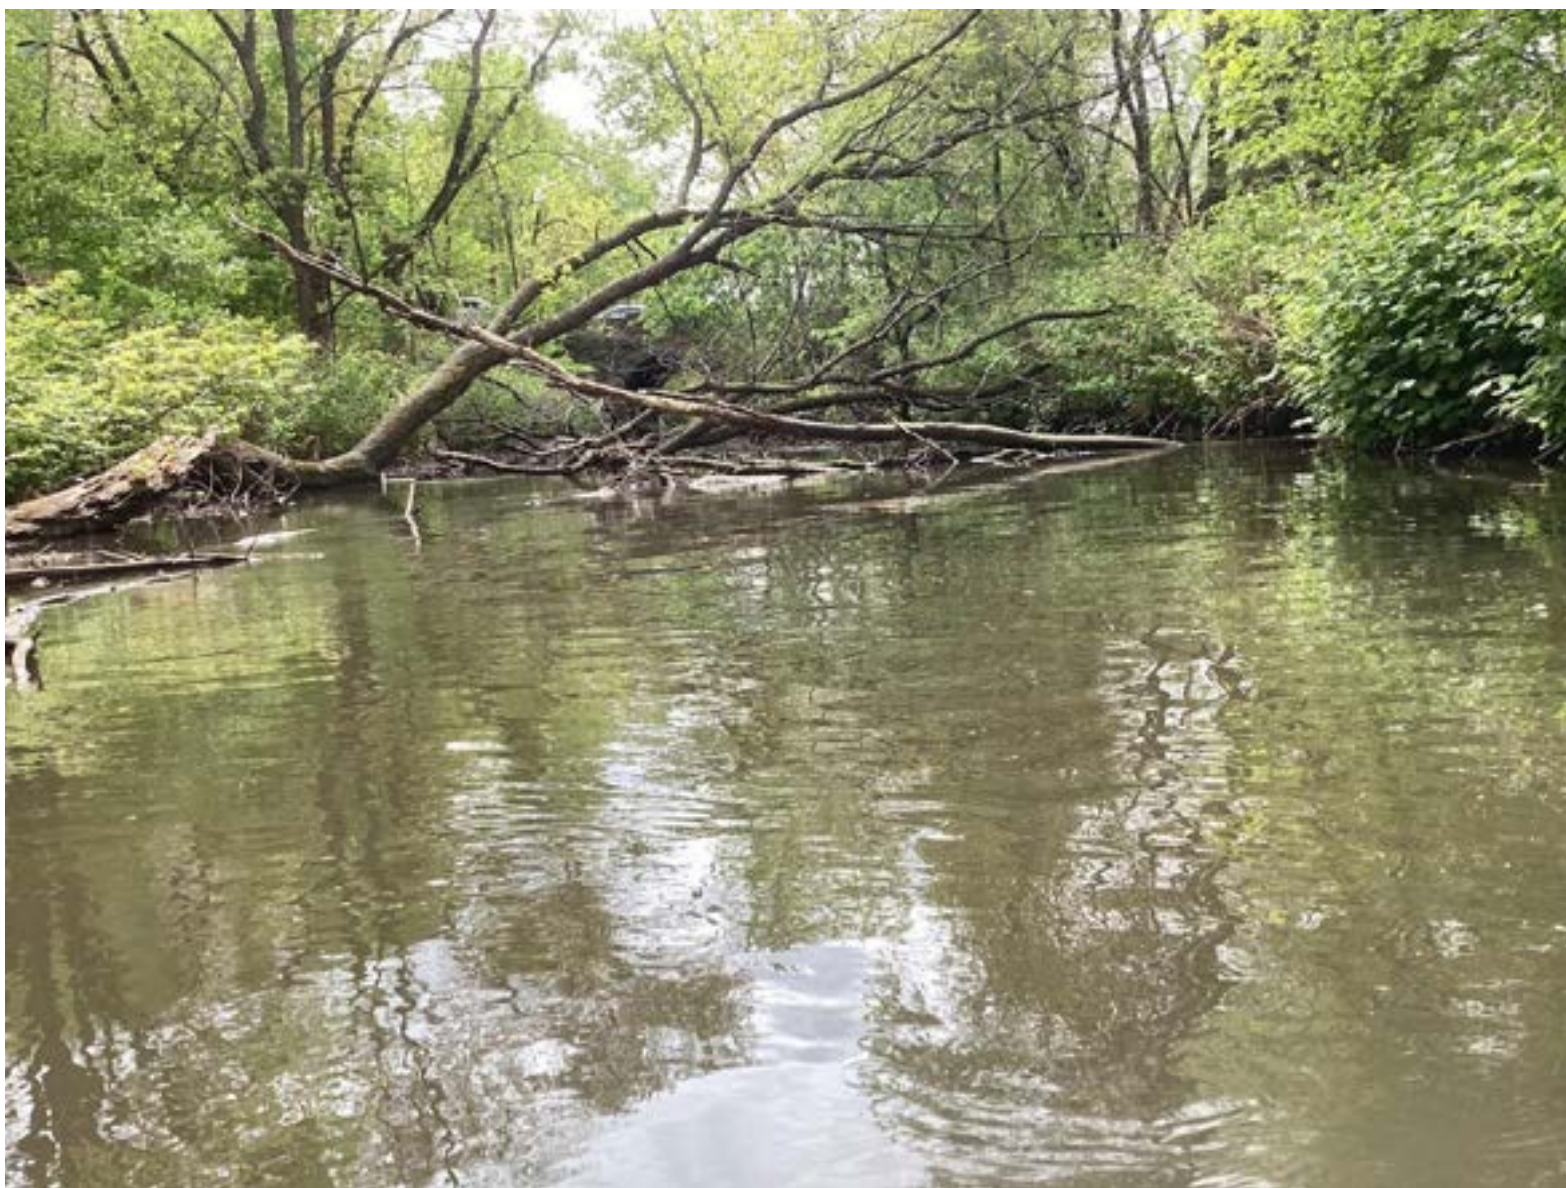
*Figure 17. Reach D. Looking upstream towards the bridge at Broadway with abundant in-channel large wood from trees fallen from the highly vegetated banks.*

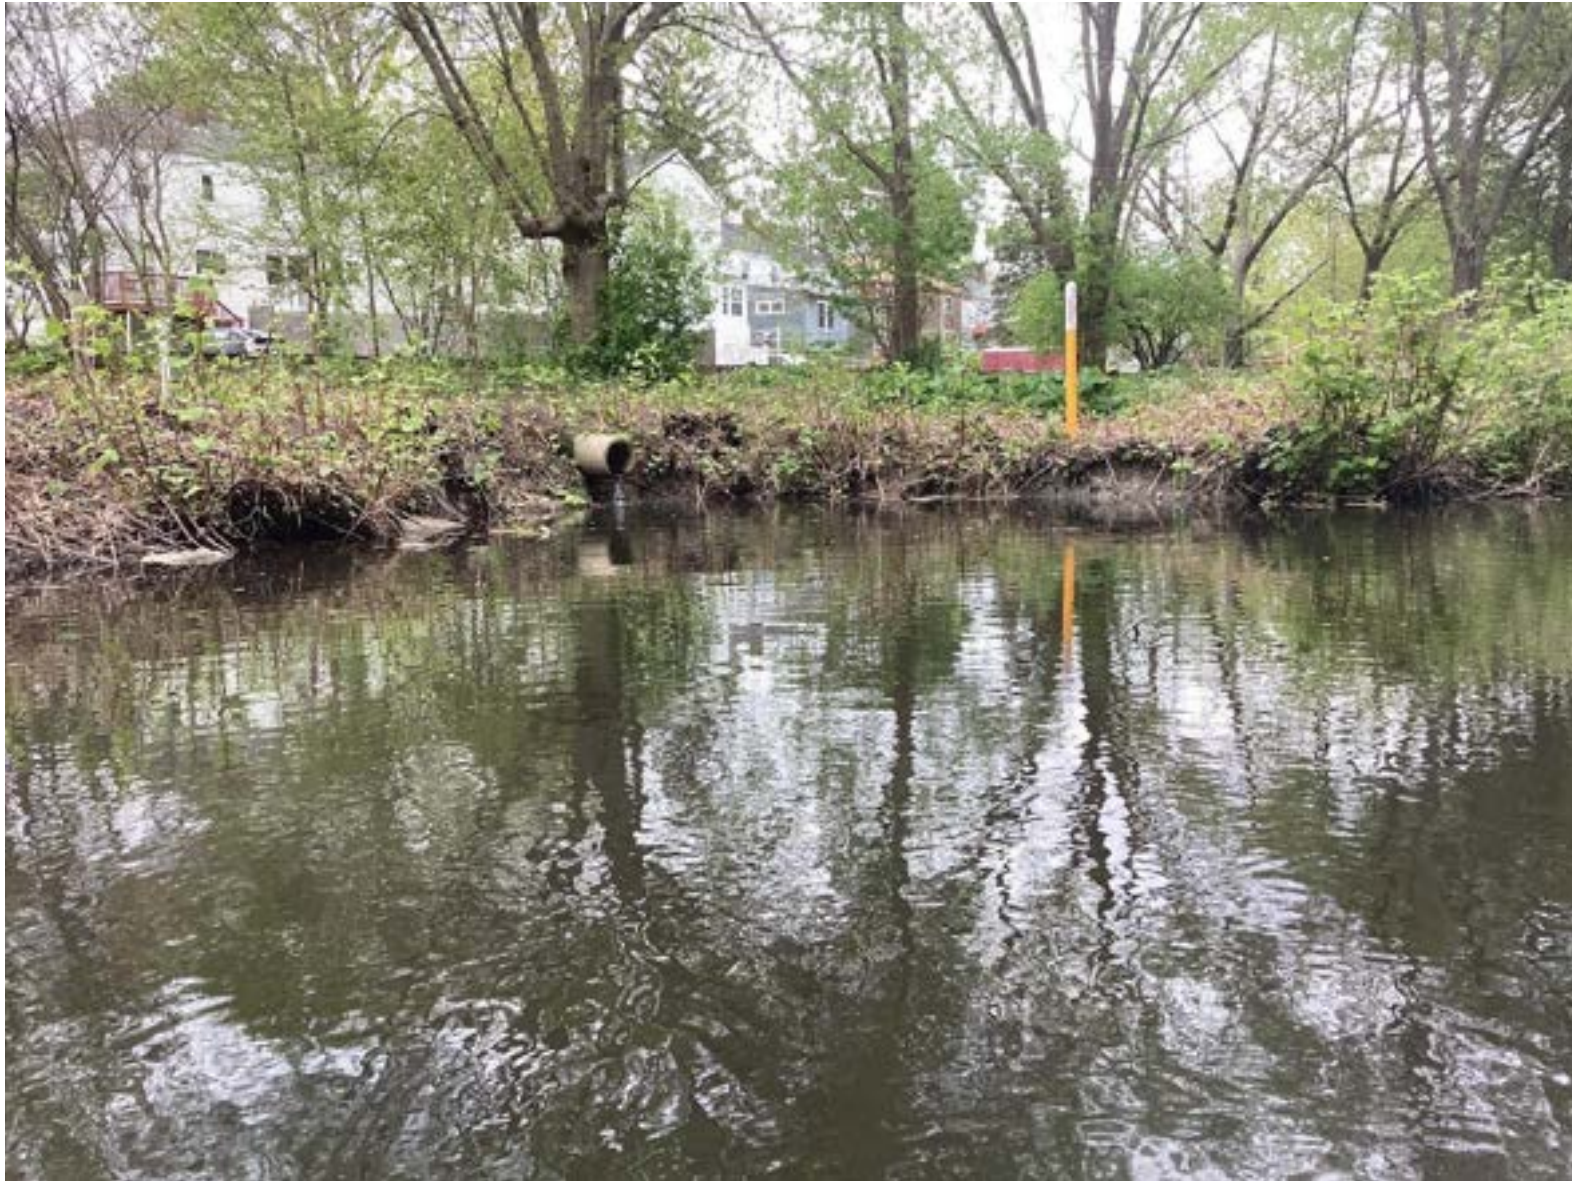
*Figure 18. Reach D. Looking downstream towards river left at a stormwater drain and bank erosion.*

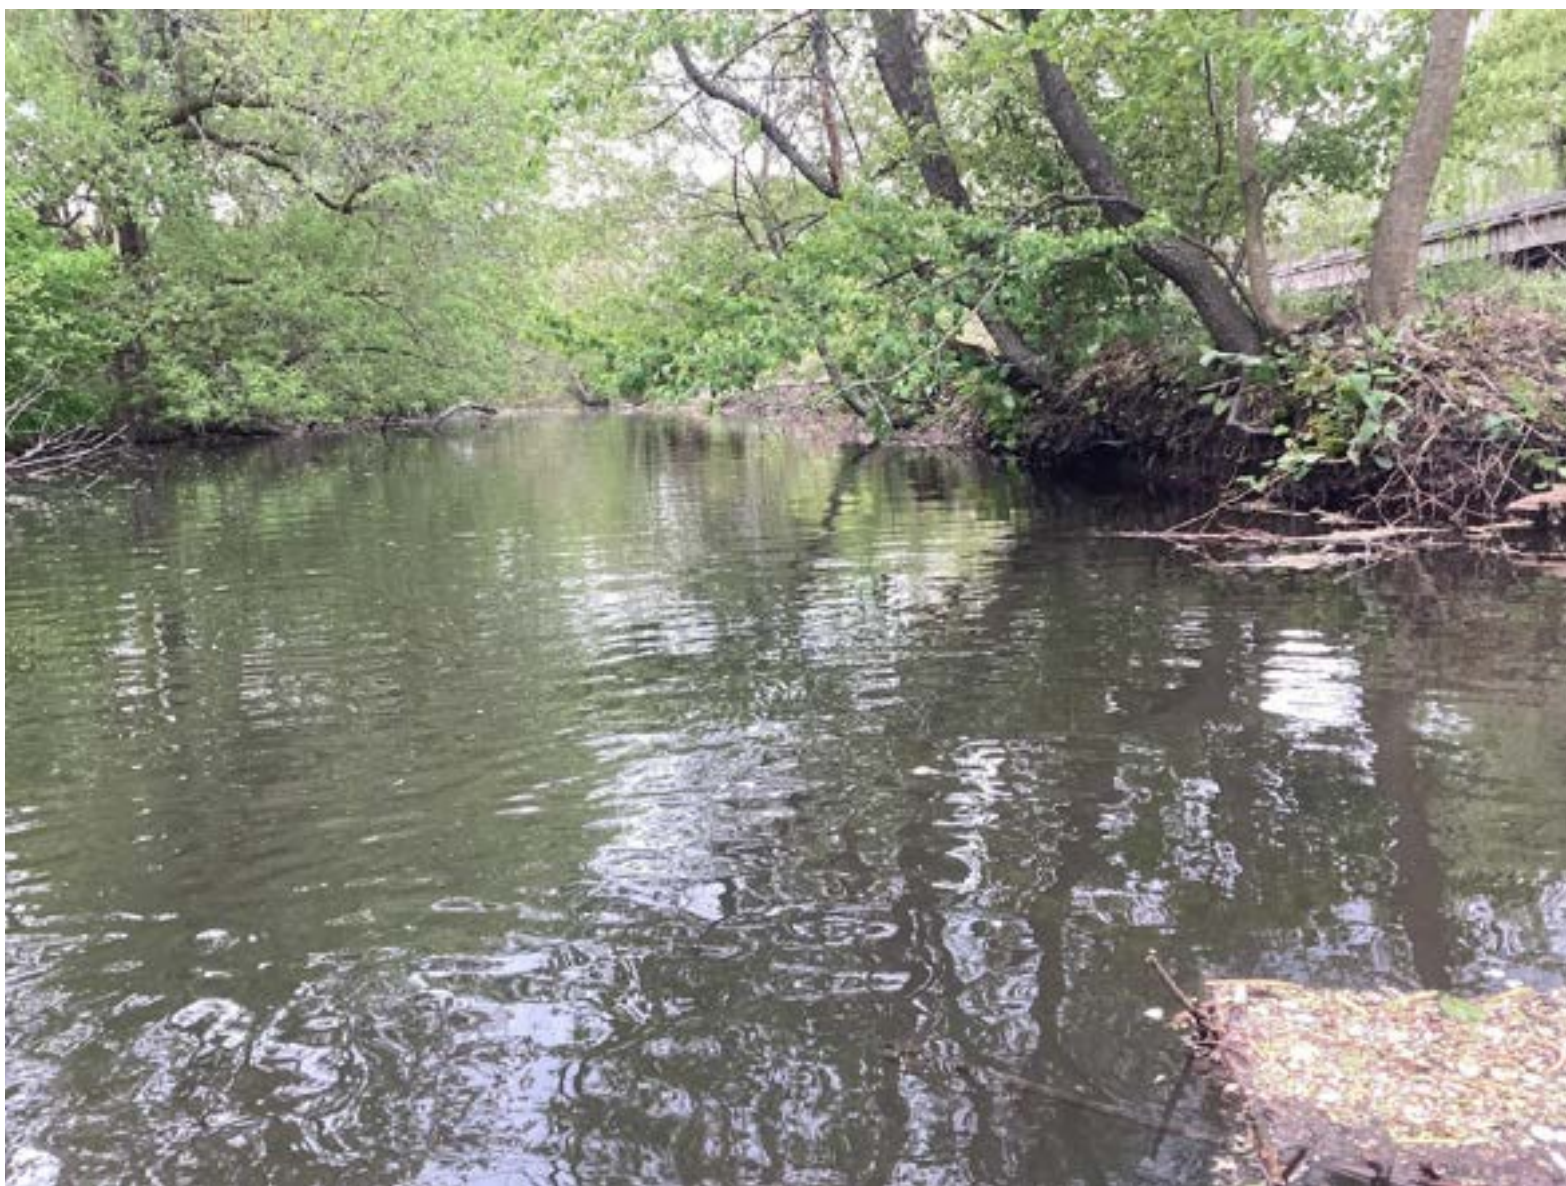
*Figure 19. Reach D. Looking upstream. The undercut banks and overhanging vegetation provide in-channel aquatic cover and habitat.*

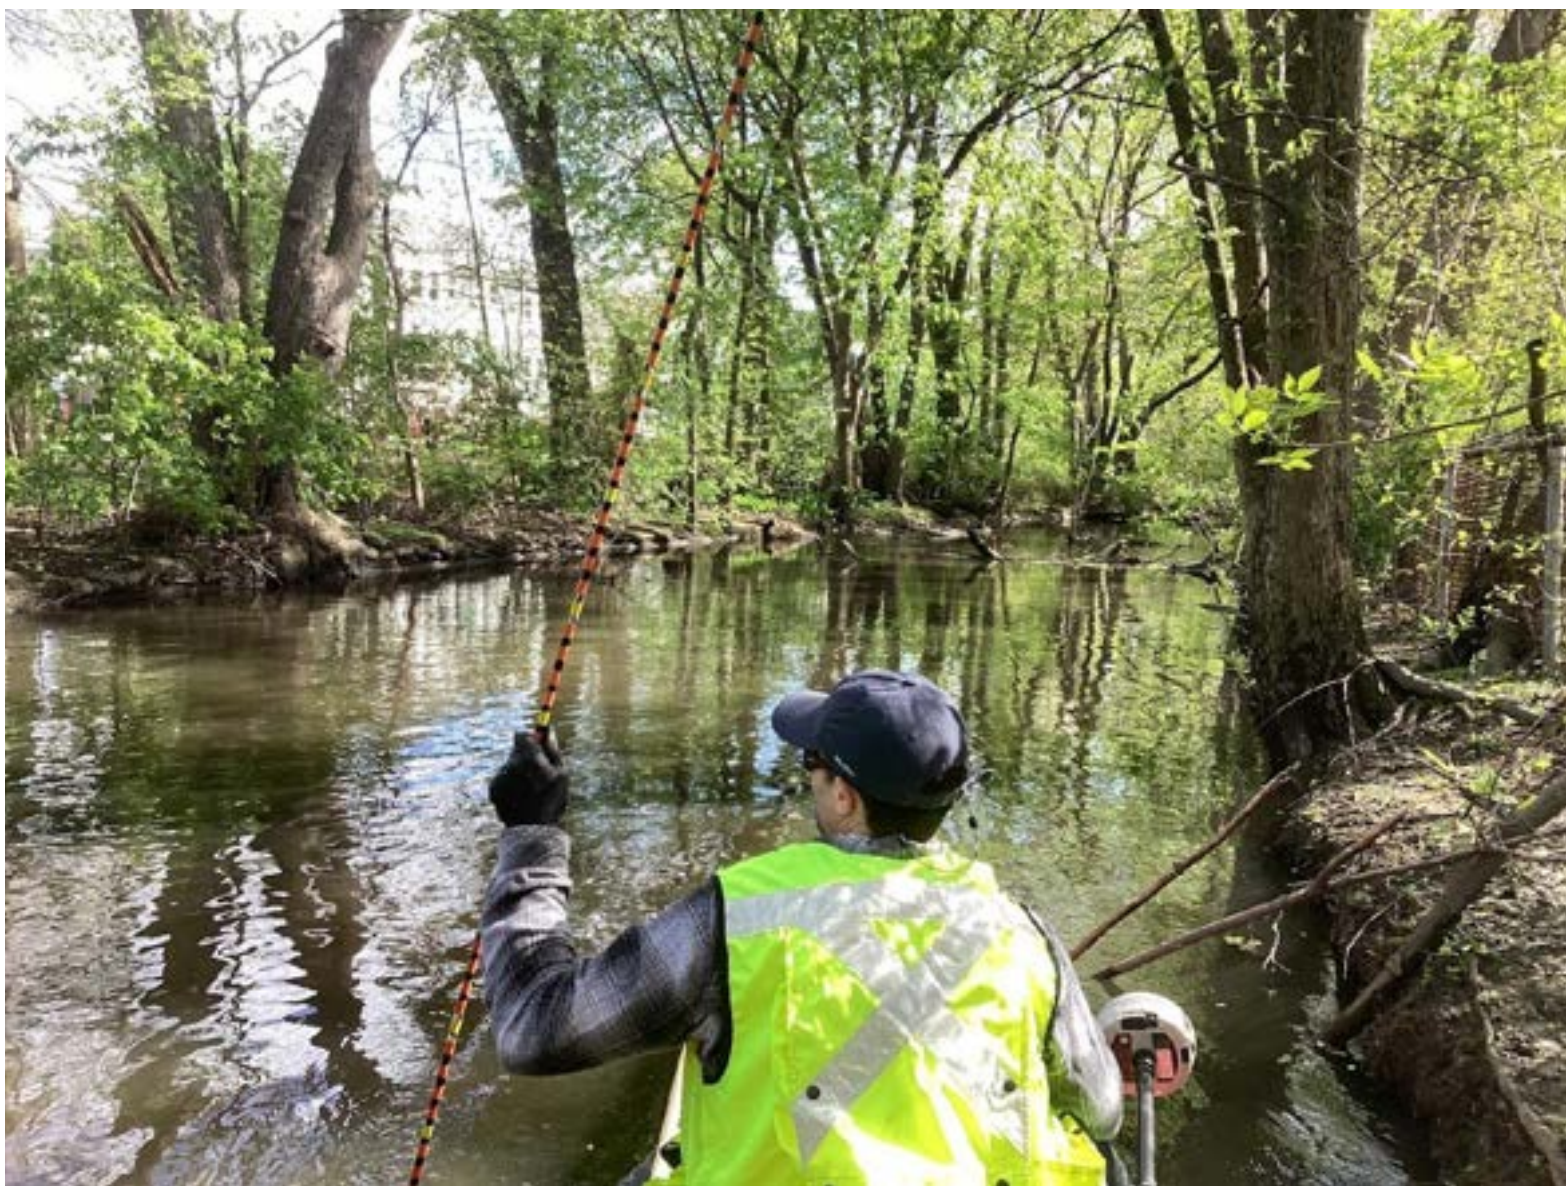
*Figure 1. Reach A, looking downstream. Measuring the depth to refusal in the channel using a flexible probing rod.*

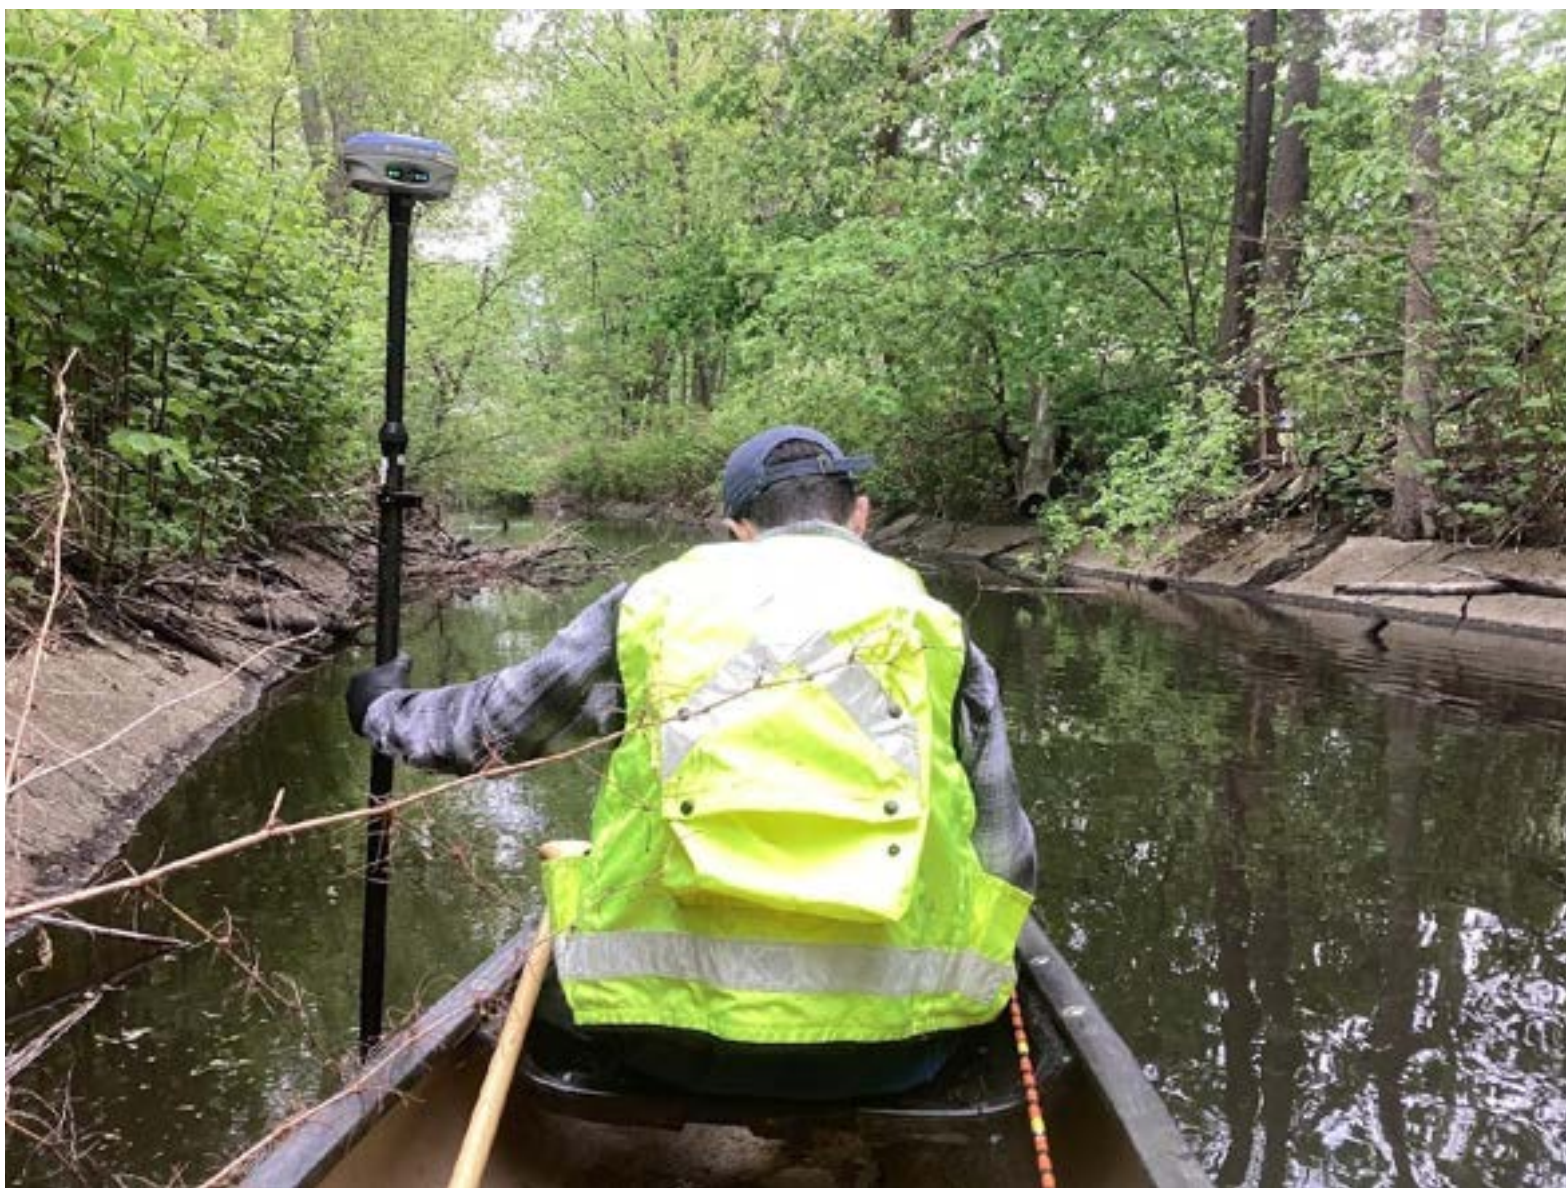
*Figure 2. Reach B, looking downstream. Measuring the bed elevation using RTK-GPS survey equipment.*

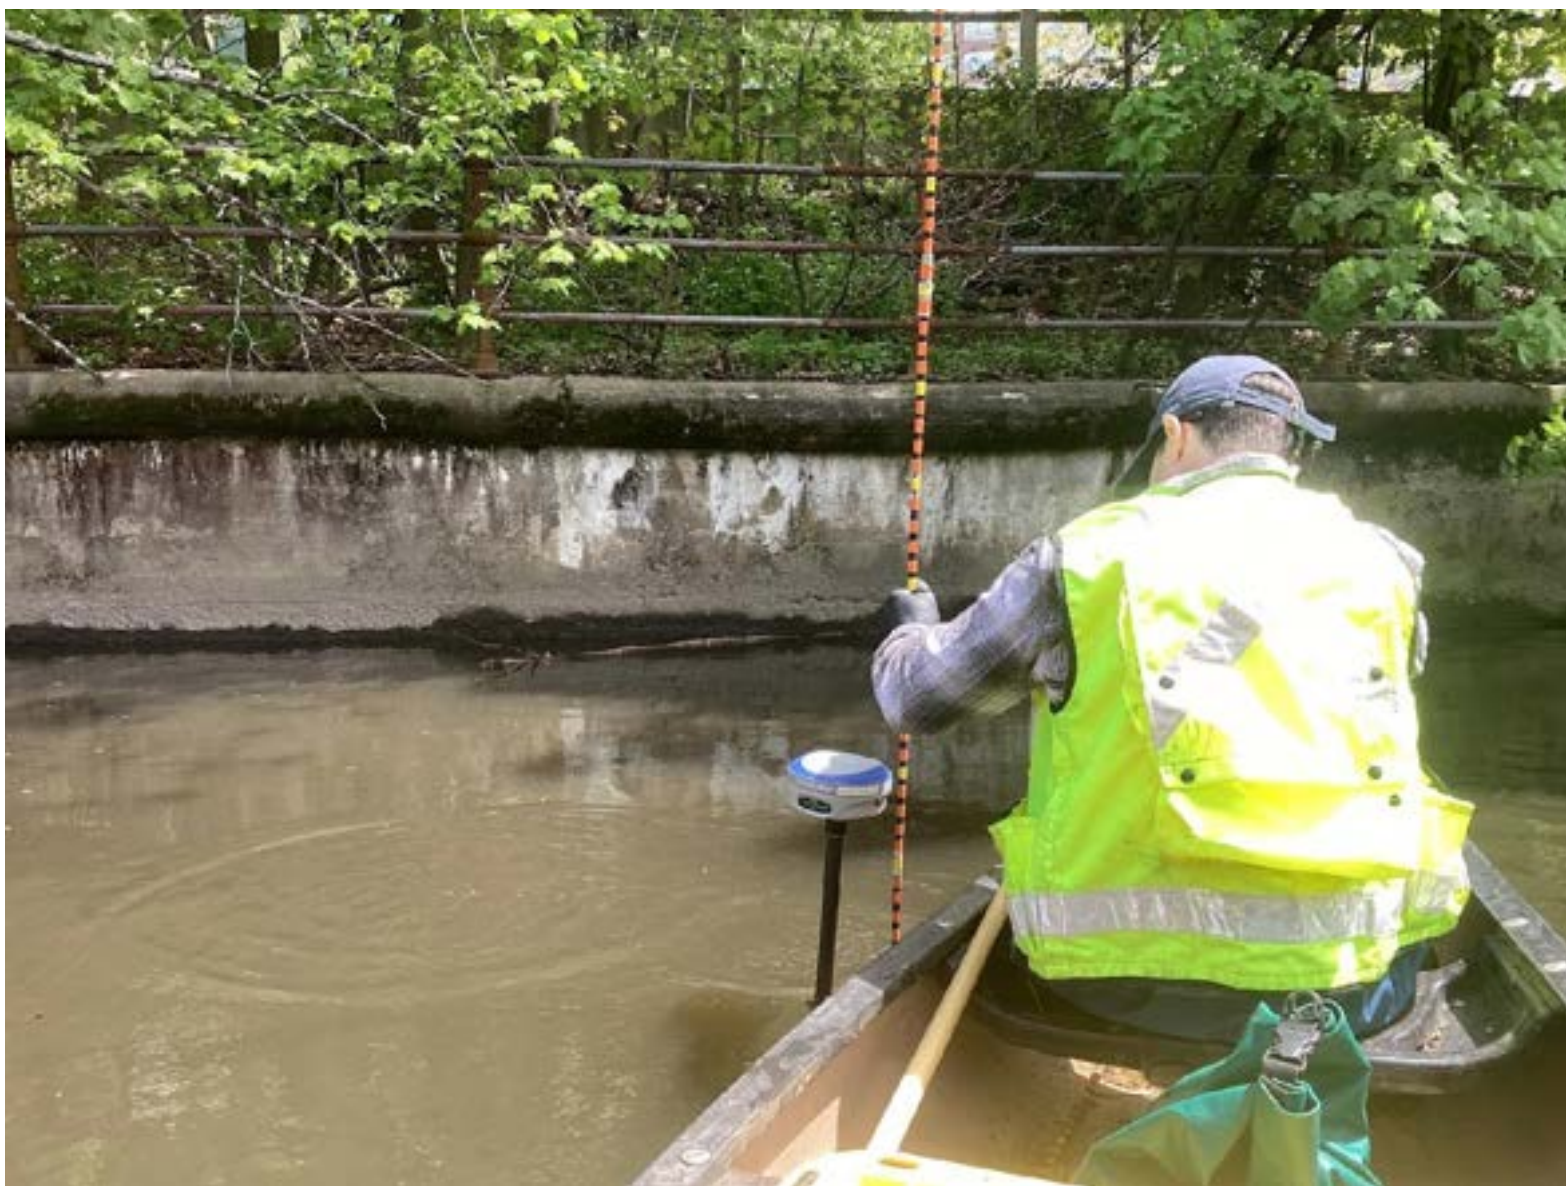
*Figure 3. Reach C, looking toward river right. Measuring depth to refusal and sediment thickness using the RTK-GPS and probing rod.*

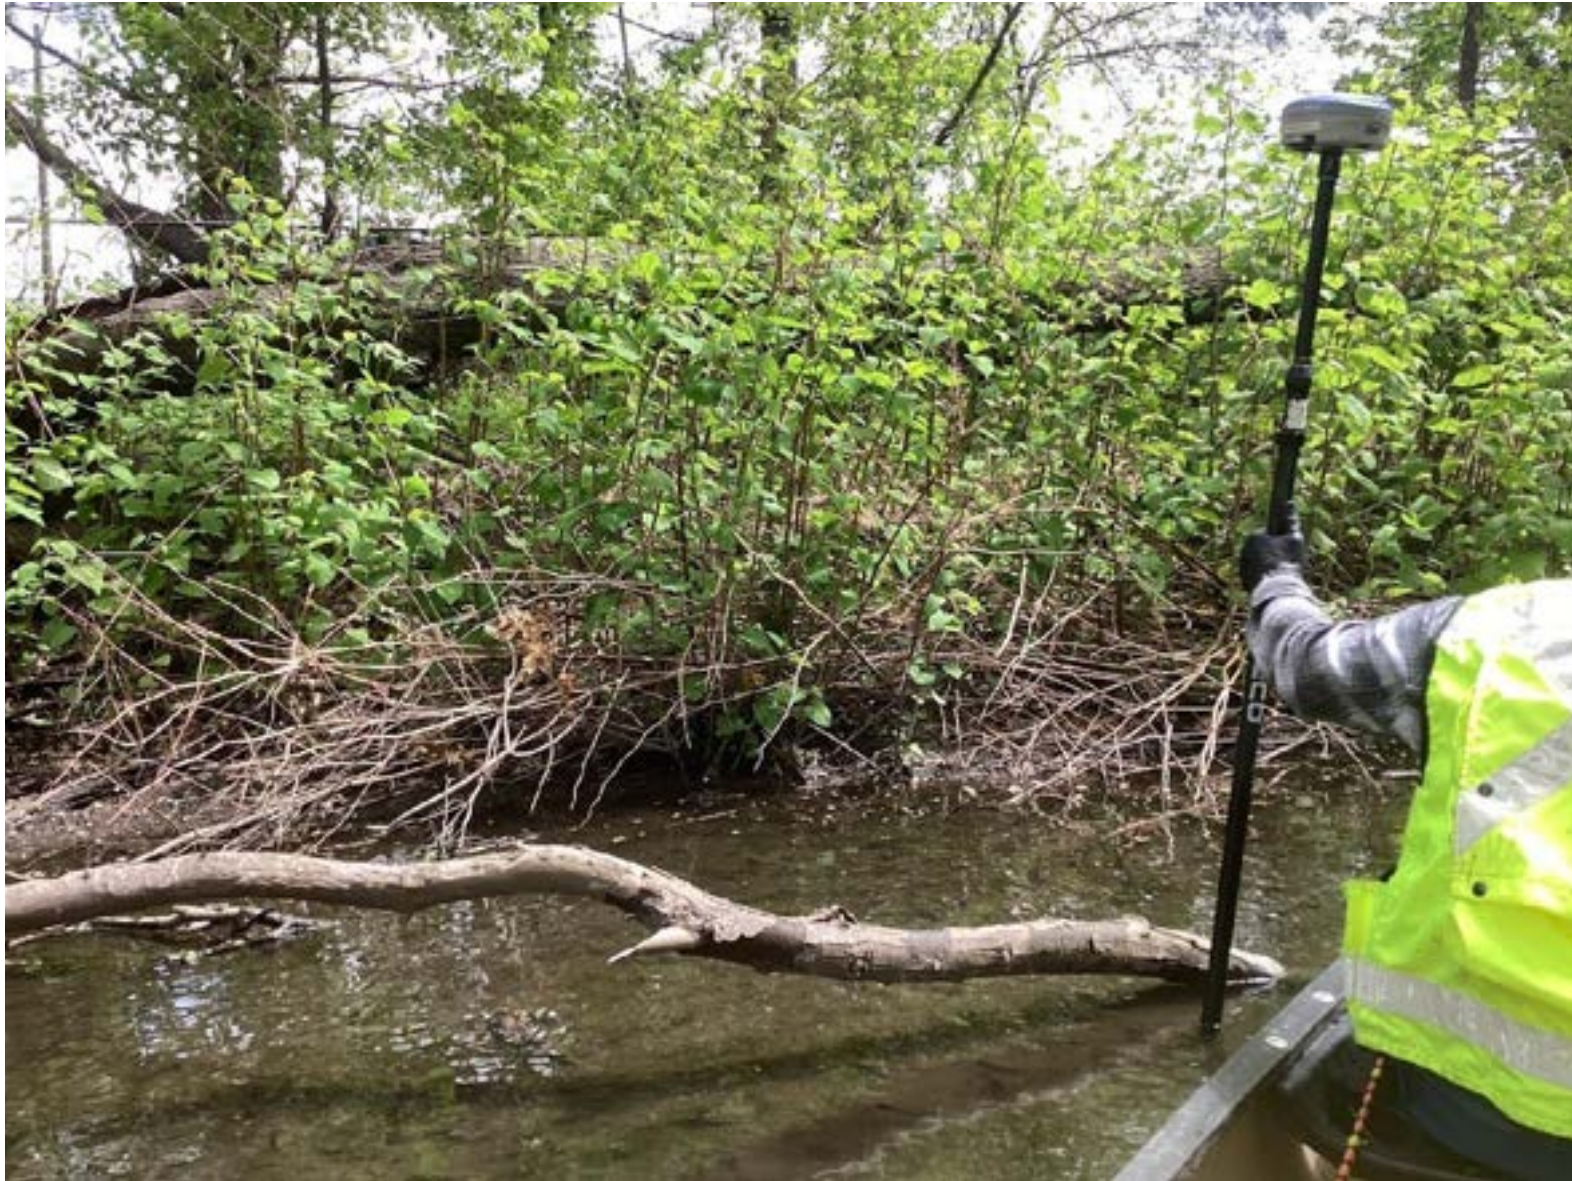
*Figure 4. Reach D, looking toward river left. Measuring the bed elevation at river right next to a downed tree limb.*
