# TECHNICAL MEMORANDUM

Project: Alewife Brook Sediment Study

Re: FINAL Sediment Sampling and Management Report

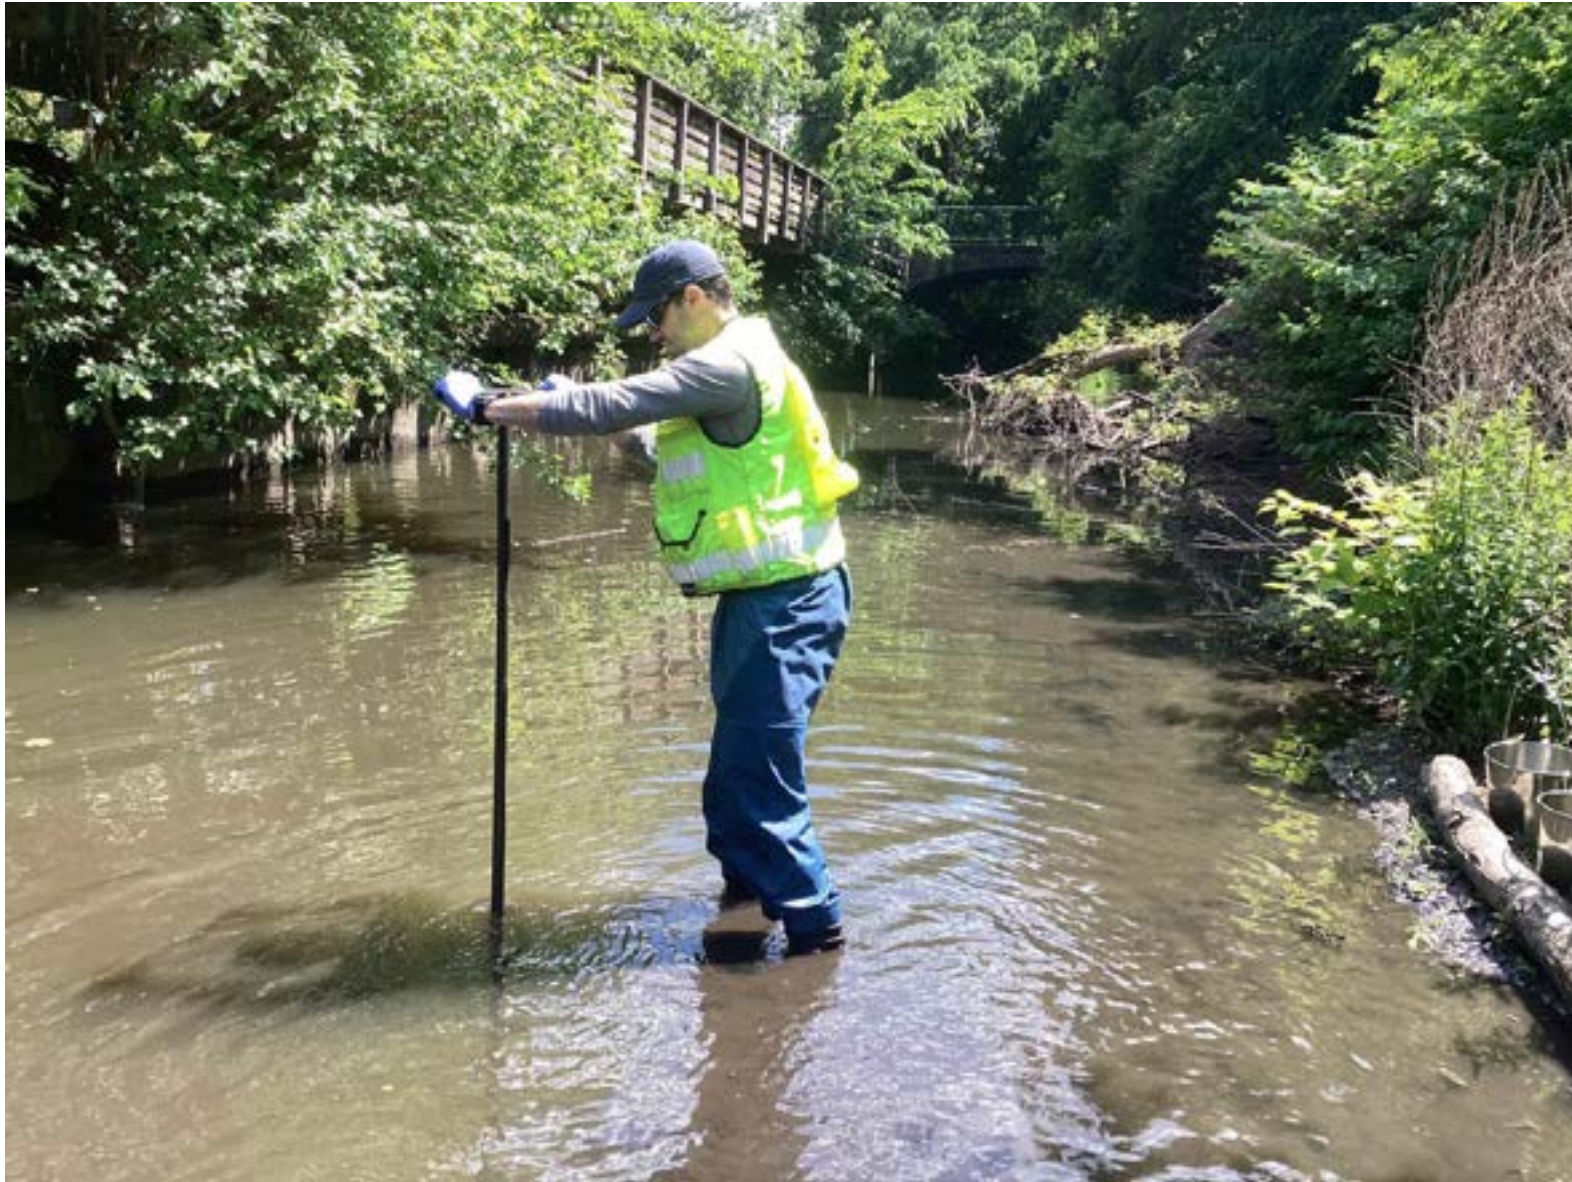
*Figure 5. Reach D, looking upstream. Collecting sediment for Sample AB6 using sediment coring tools.*

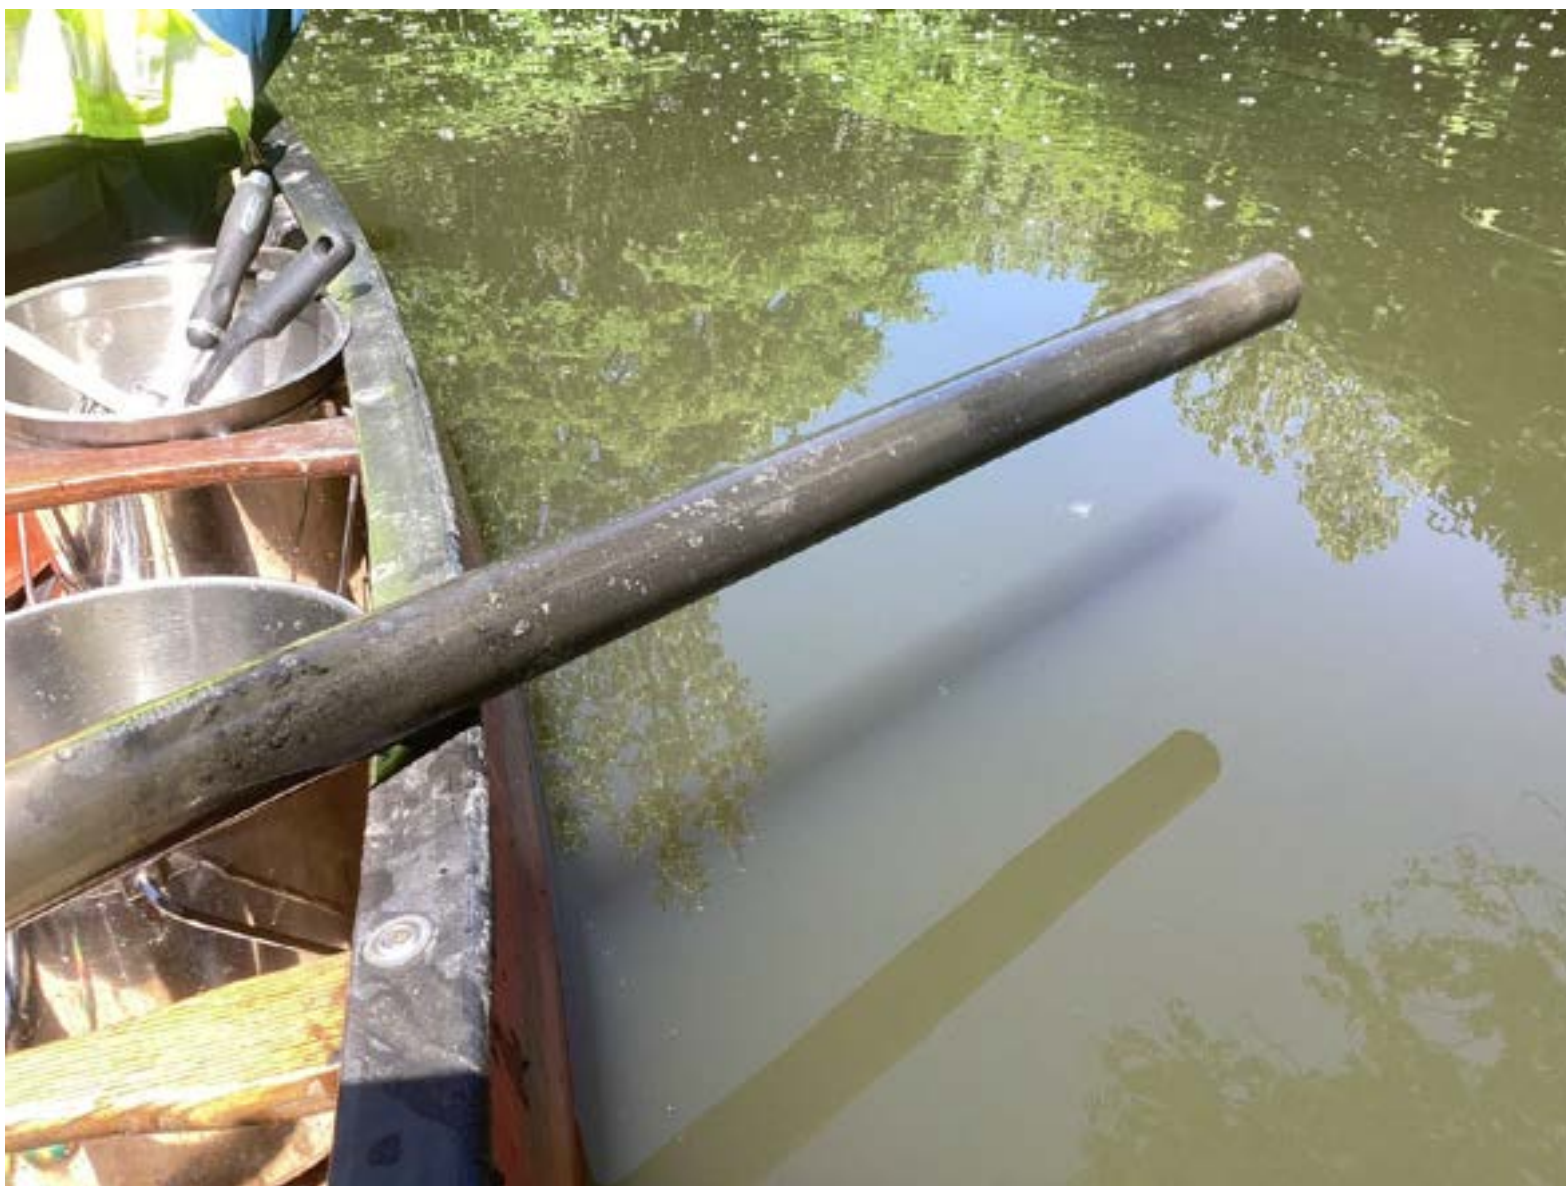
*Figure 7. Sediment core for sample AB2 upstream of Rt. 2.*

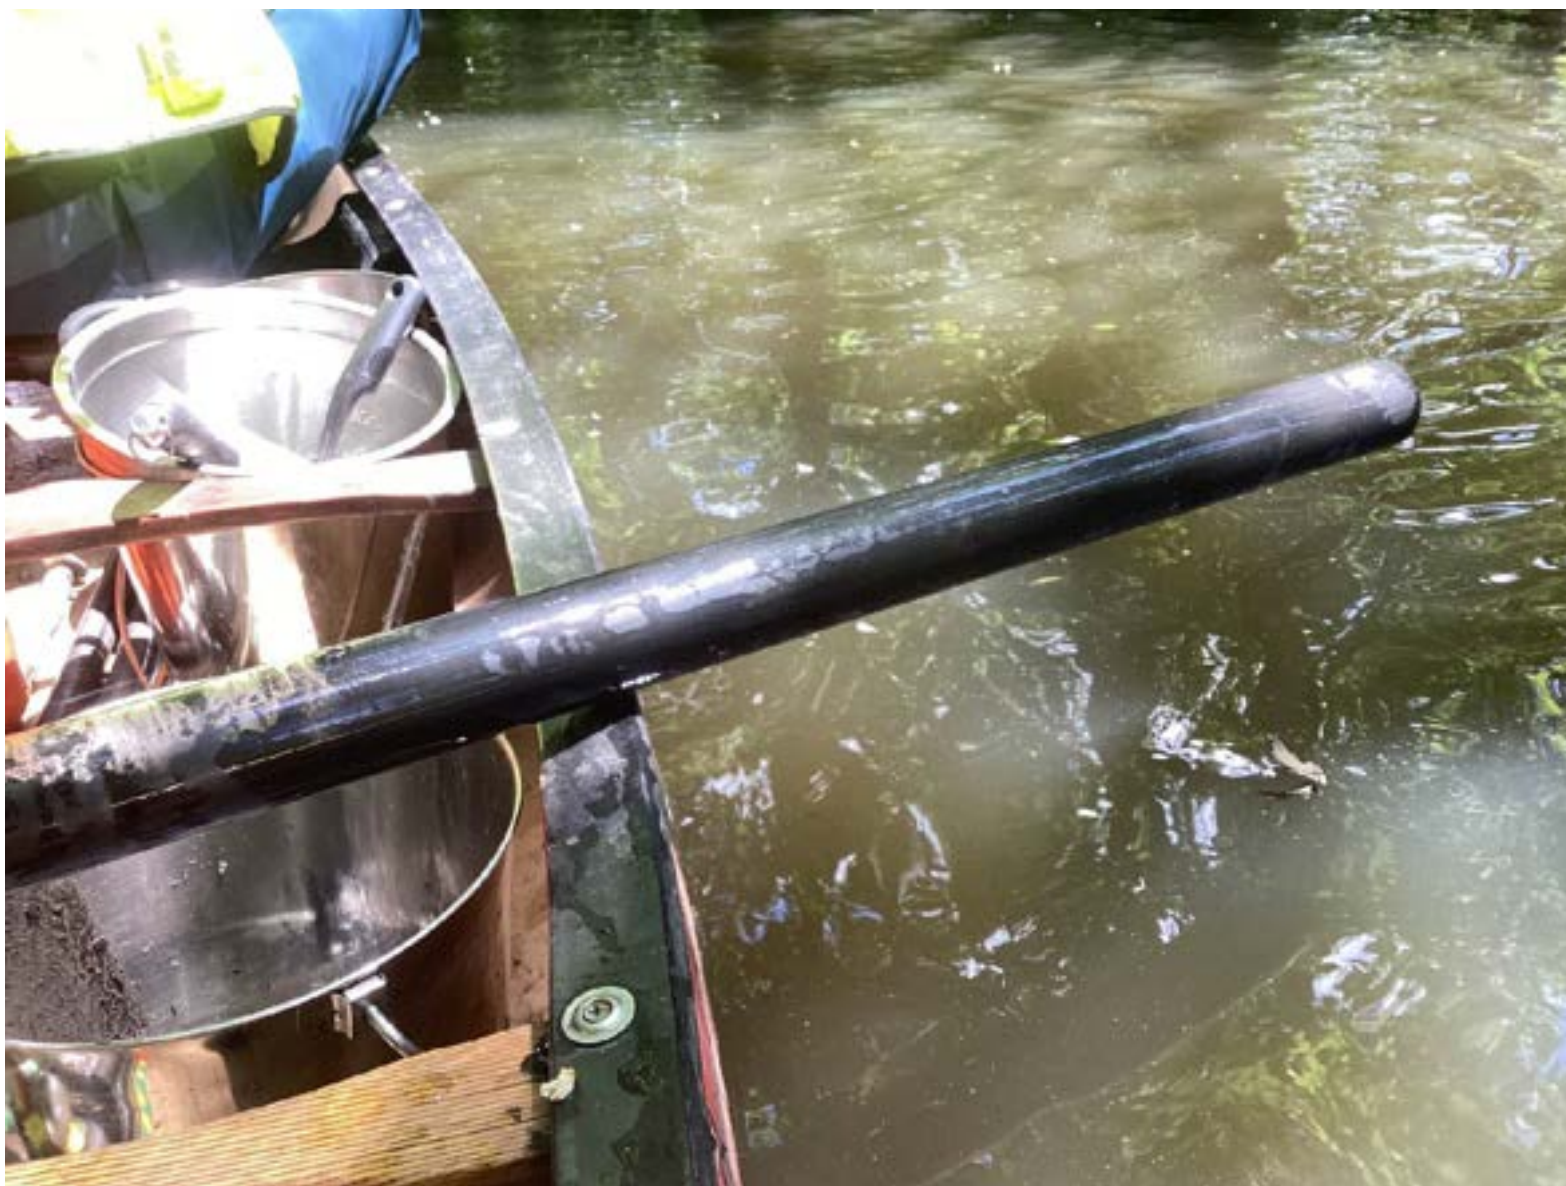
*Figure 9. Reach B. Sediment core extracted for Sample AB3.*

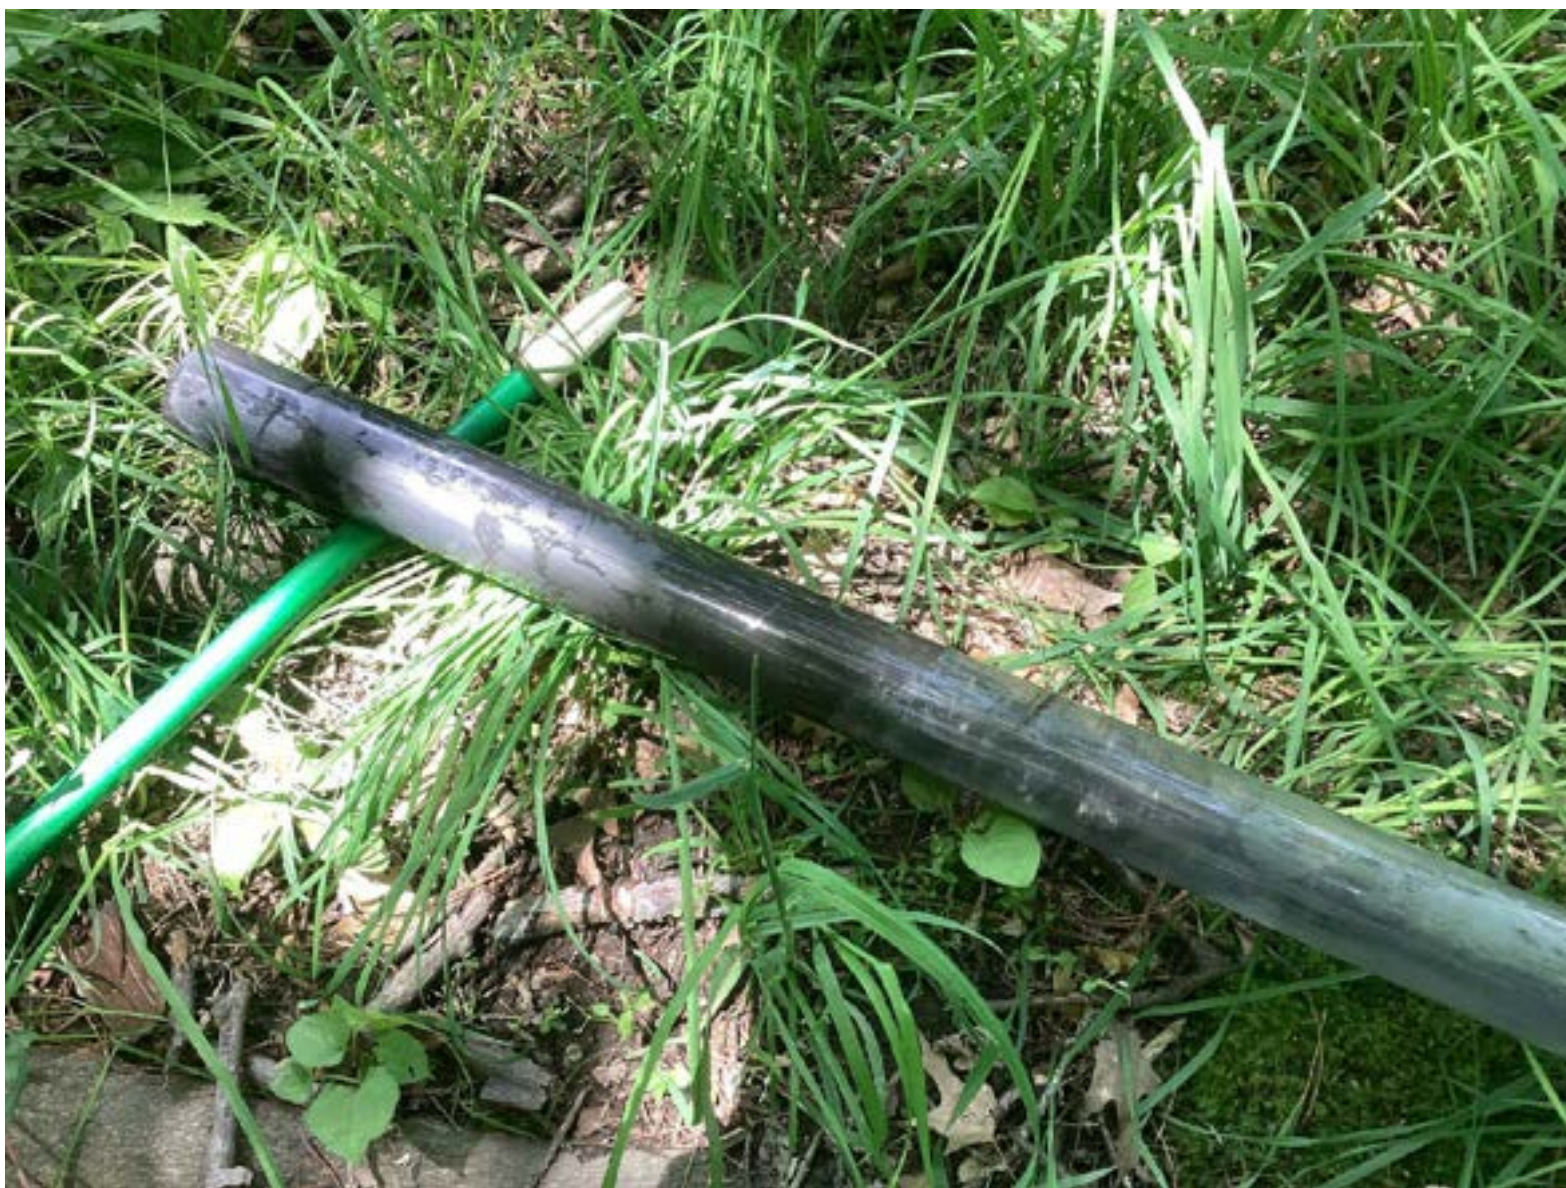
*Figure 11. Sediment core extracted for Sample AB4.*

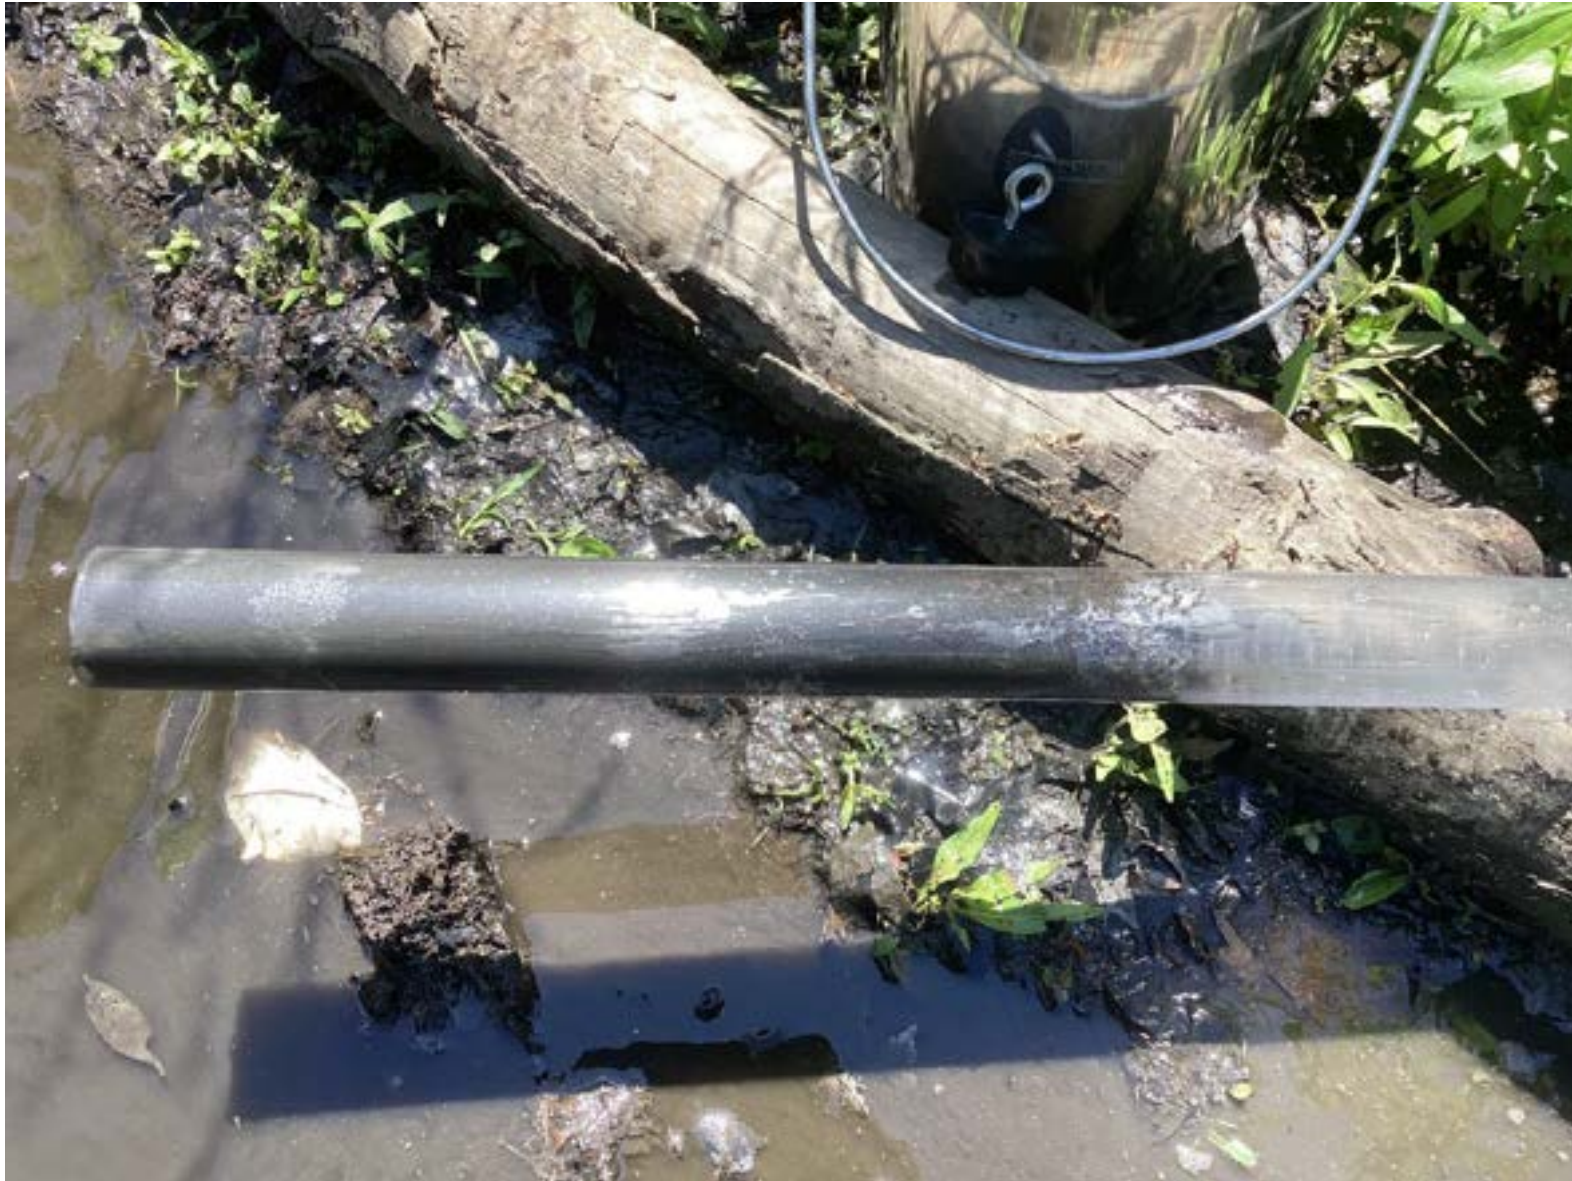
*Figure 14. Sediment core extracted for AB6.*
