| | Mystic River Watershed Association | | Stantec Consulting Services Inc. |
| Project/File: | 203402558 | Date: | June 28, 2024 |

**Reference: Alewife Brook Hydraulic and Stream Improvement Study – Conceptual Design**

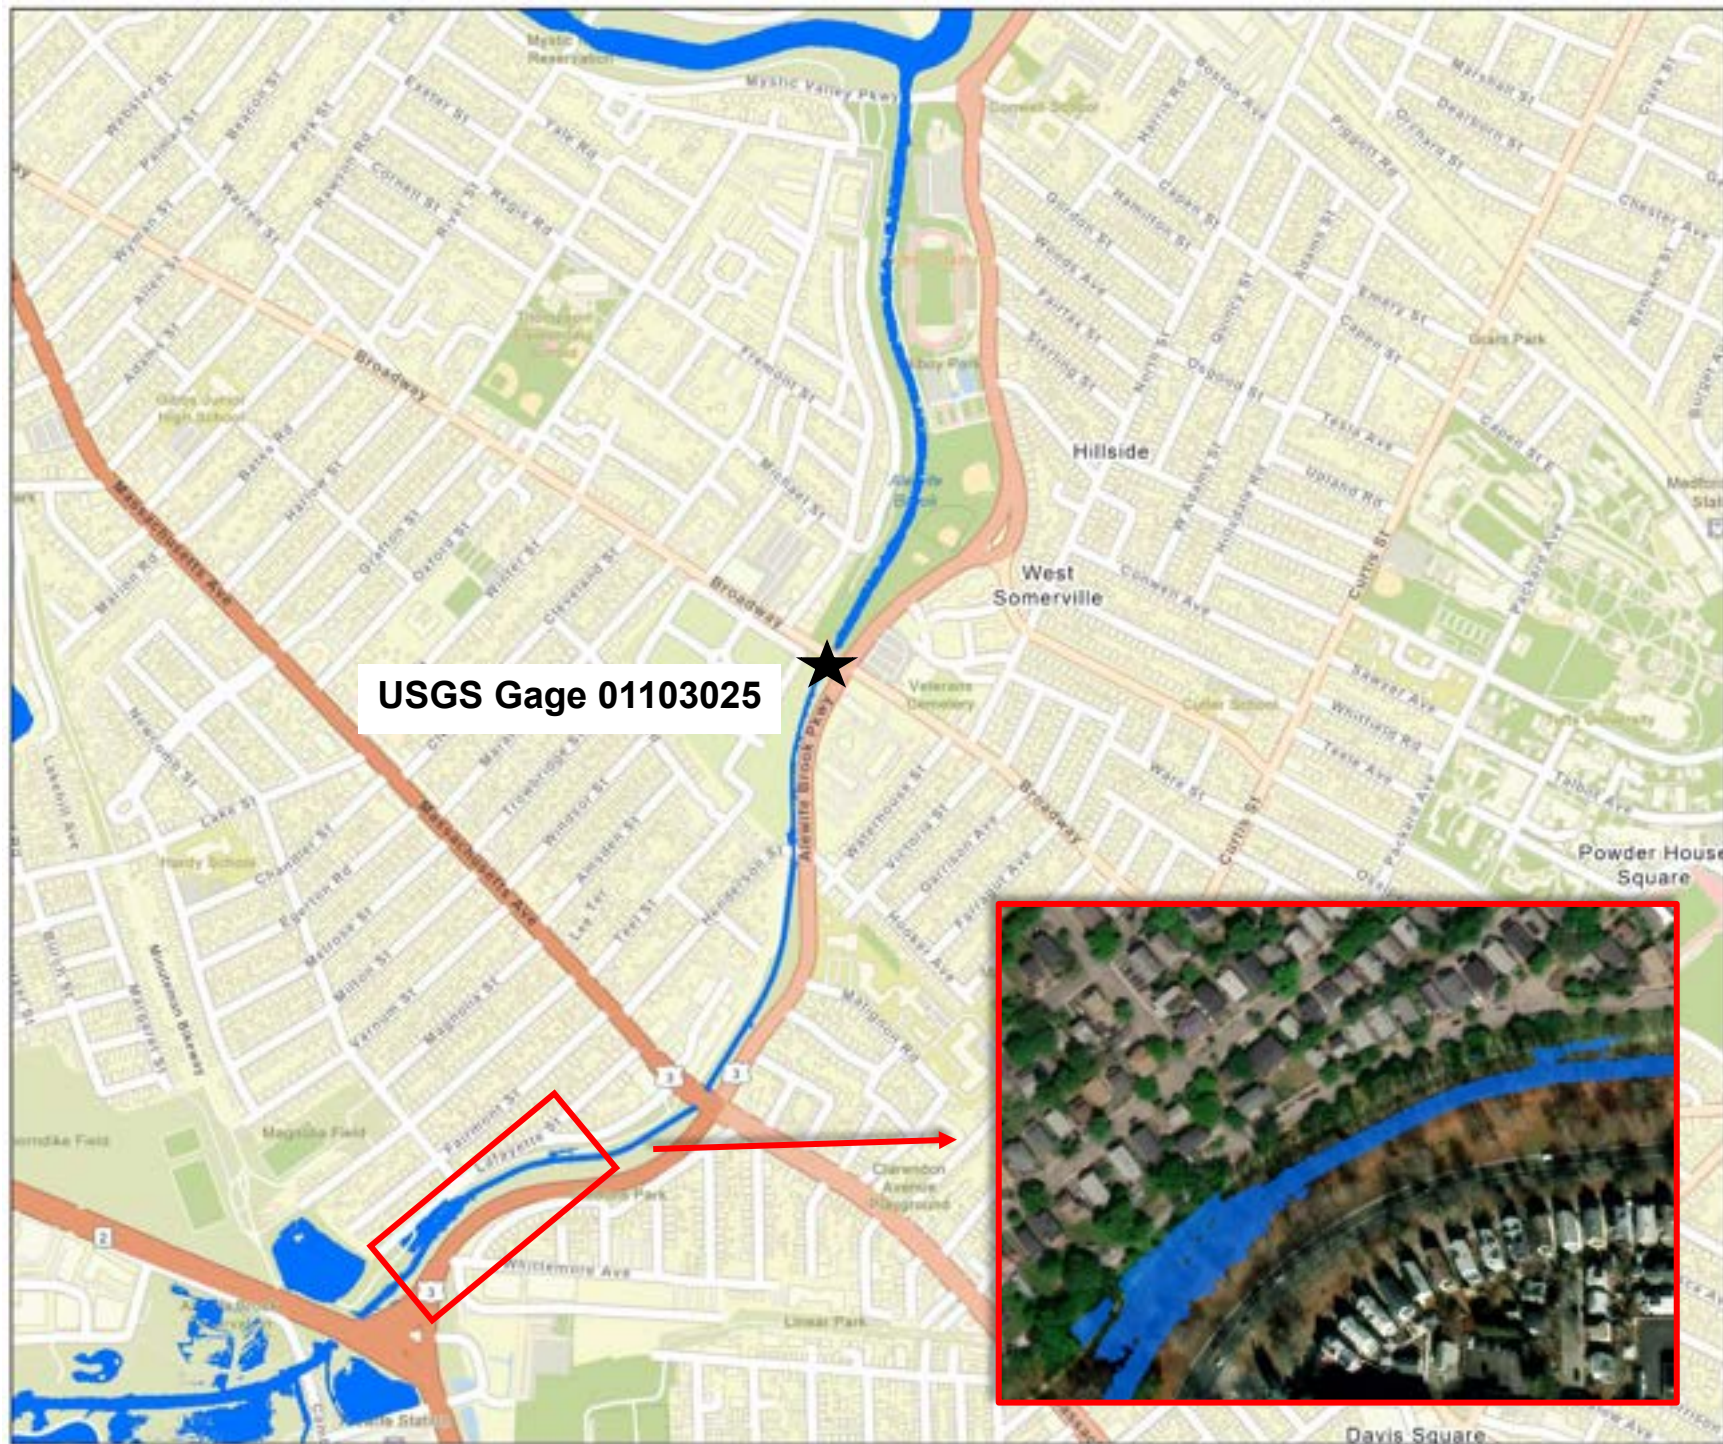
Figure 3. Existing Conditions Flood Extent Map – August 8<sup>th</sup>, 2023

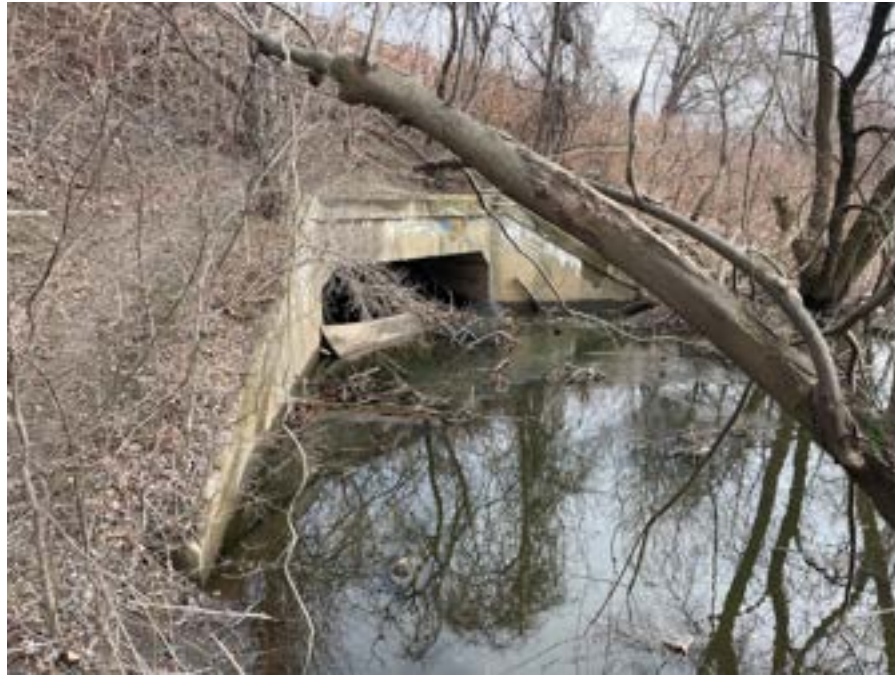
Photo 7. Concord Turnpike inlet at crossing structure, with debris jam

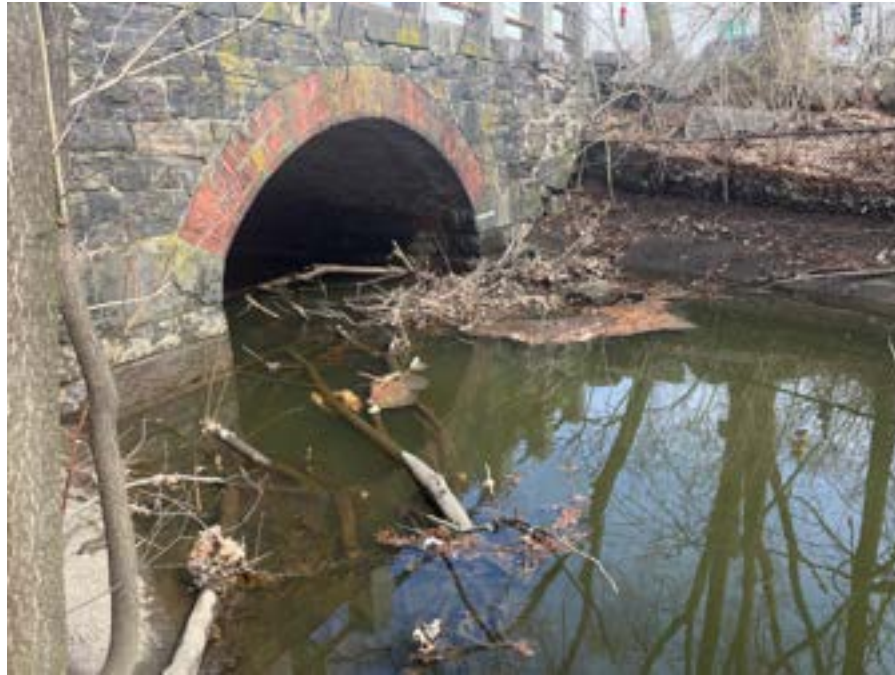
Photo 11. Massachusetts Avenue inlet of crossing structure, with debris jam.

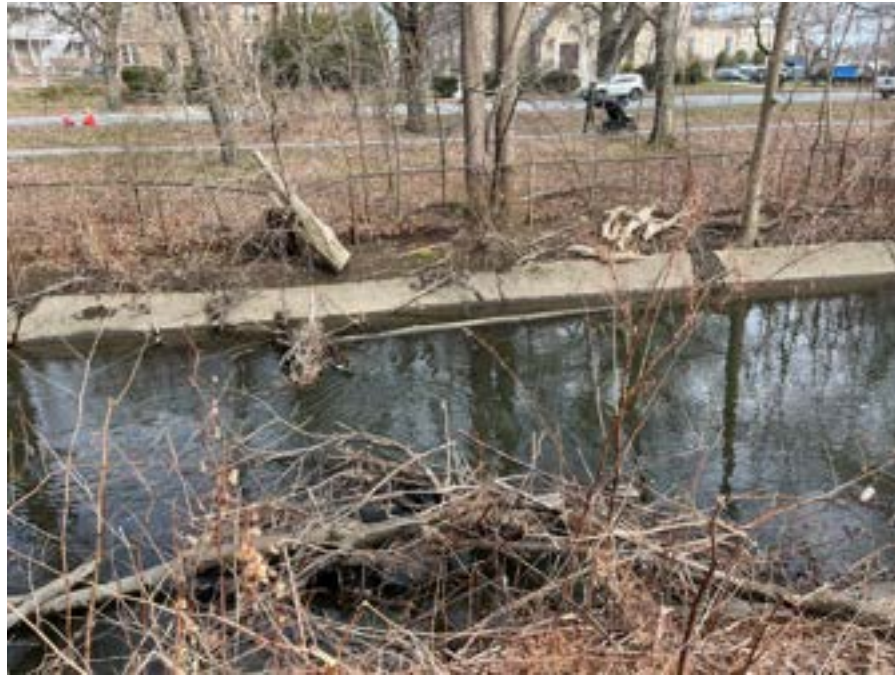
Photo 17. Typical debris jam in Stream Segment 3.

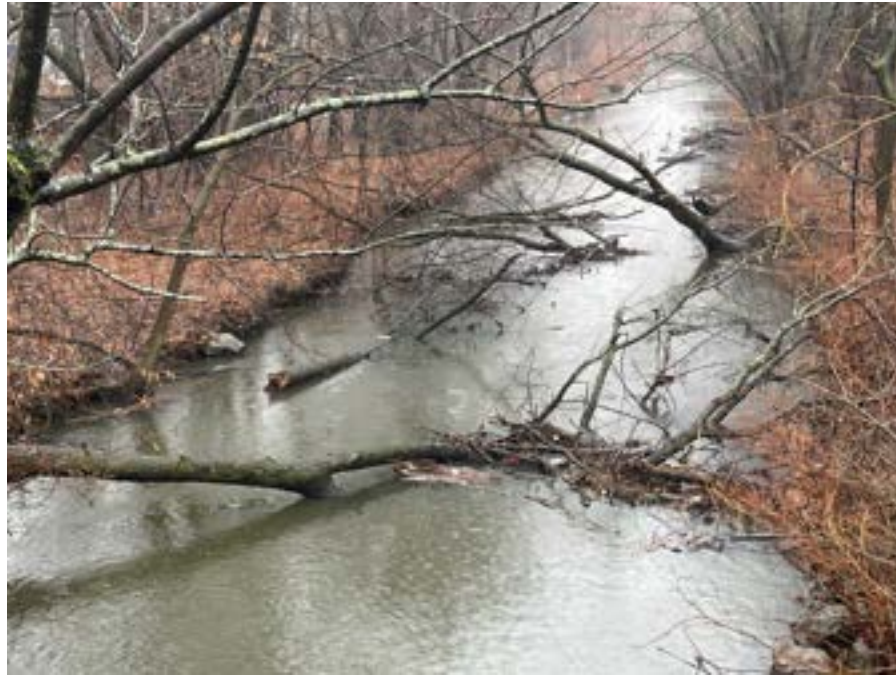
Photo 27. Looking downstream from Broadway at typical debris jams in Stream Segment 5.
